Building Safety Inspection Report Form Amended 03/15/12
STRUCTURAL

Building / Structure address Plaza South Condominium
 Legal description 494319AM0010 Plaza South Condo Common Area 335 Units 494319AM0010 thru 494319AM3360
 Folio # of Building /Structure 494319AM0000
 Owner's name Plaza South Condominium Common Area 335 Units
 Owner's mailing address 4280 GALT OCEAN DRIVE, Ft. Laud., FL

Inspection Firm or Individual BROMLEY COOK ENGINEERING INC.
 Address 5440 NW 33 AVE SUITE 100, FT. LAUD., FL 33309
 Phone 954-772-4624

Inspection Commencement Date 08/23/21 Inspection Completion Date 09/ 17/ 21
 Inspection made by David Dolbee

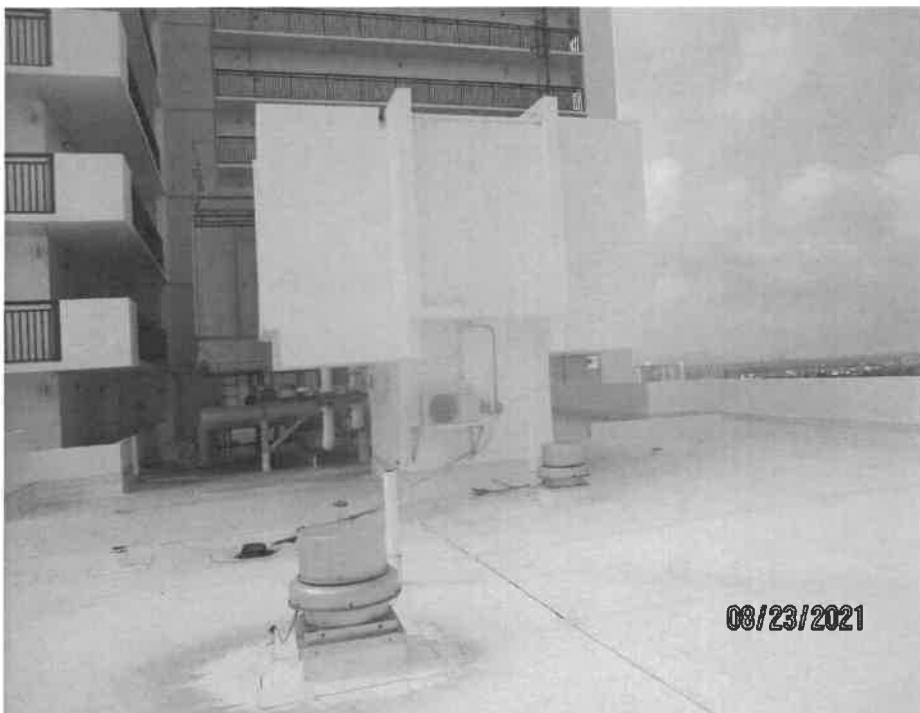
Photo at left depicts the elevator tower on the roof of the 16-story portion, which is the north portion. This view is facing southward.

The building is recently painted and the roof top structure and the parapet are in good condition.

Note the roof drain, the roof top ventilator, and the single-ply roof membrane are all visible on this roof area.

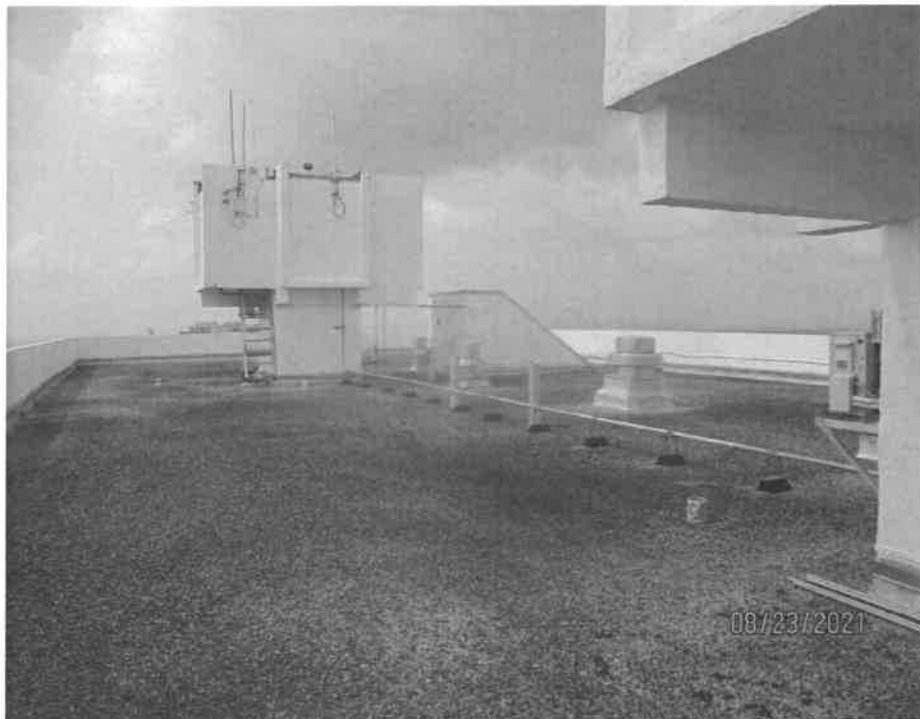
Photo at left depicts the 2 elevator towers on the roof of the 30-story portion of the building, which is the south portion. This view is facing southward.

The building is recently painted and the structural components on the roof are in good condition.

This roof portion has gravel ballast over the roof membrane, which is intact and in visibly good condition.

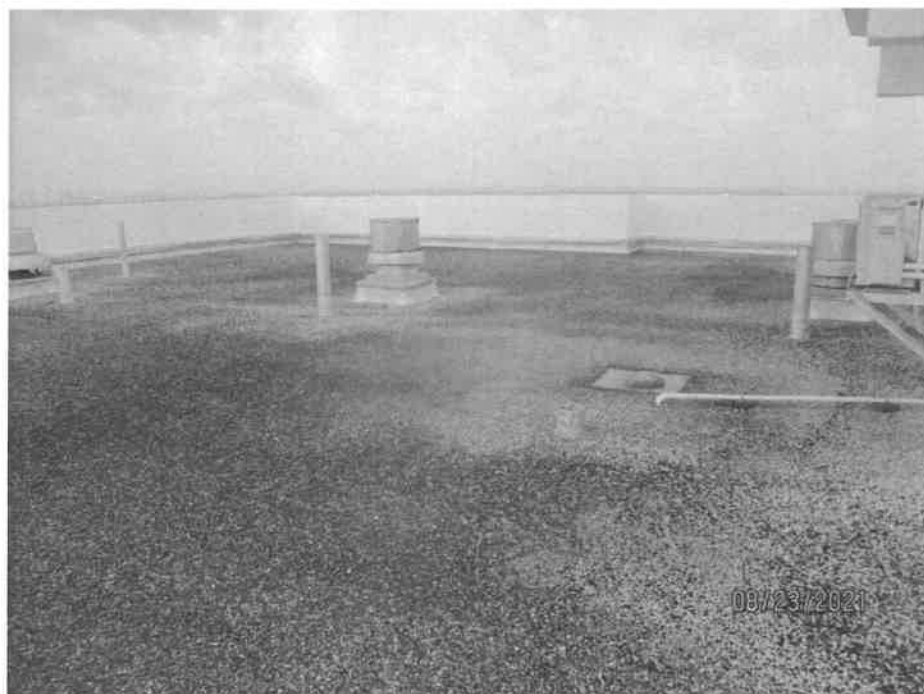
Photo at left depicts the roof for the 30-story portion with the roof drain in the center.

The roof top mechanical equipment was found anchored and secured in place.

The roof, parapet walls, and elevator towers were all found to be structurally sound and in good condition.

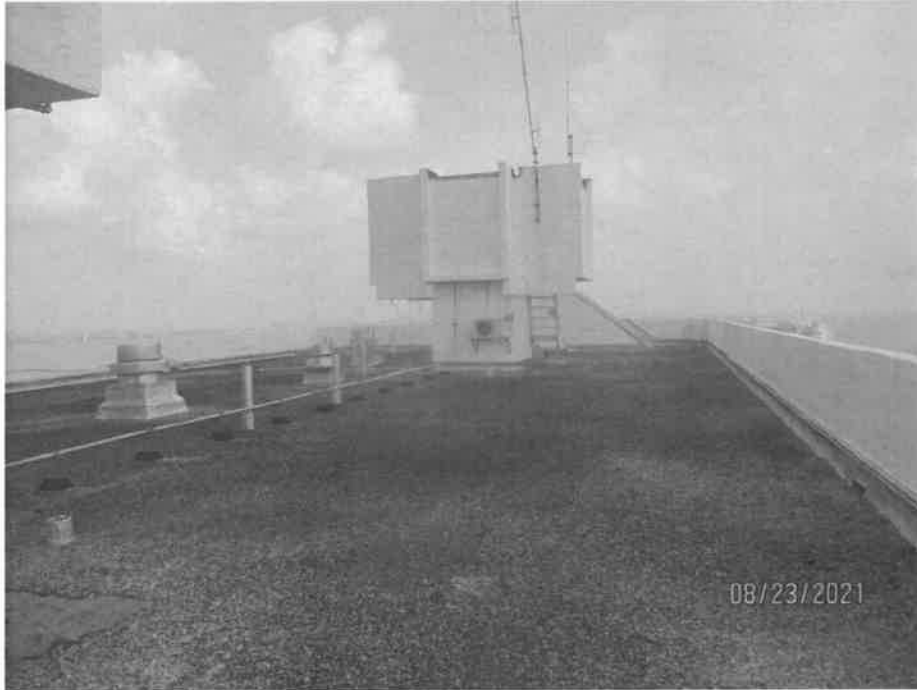
Photo at left depicts the elevator tower on the roof of the 30-story portion of the building, which is the south portion. This view is facing northward.

The steps leading up to the elevator machine room and the machine rooms were found to be in structurally good condition.

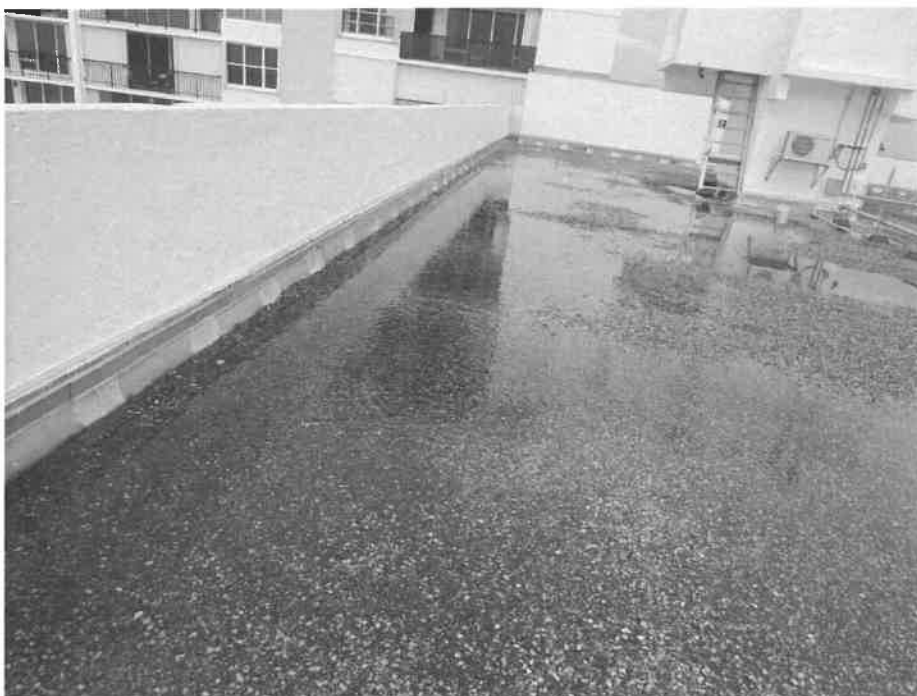
Photo at left depicts the elevator tower on the roof of the 28-story portion of the building, which is the east portion. This view is facing westward.

This photo was taken following a heavy rain storm. No water leaks were evident and the roof appeared in good condition.

This roof portion is likely a coal-tar pitch membrane with gravel ballast.

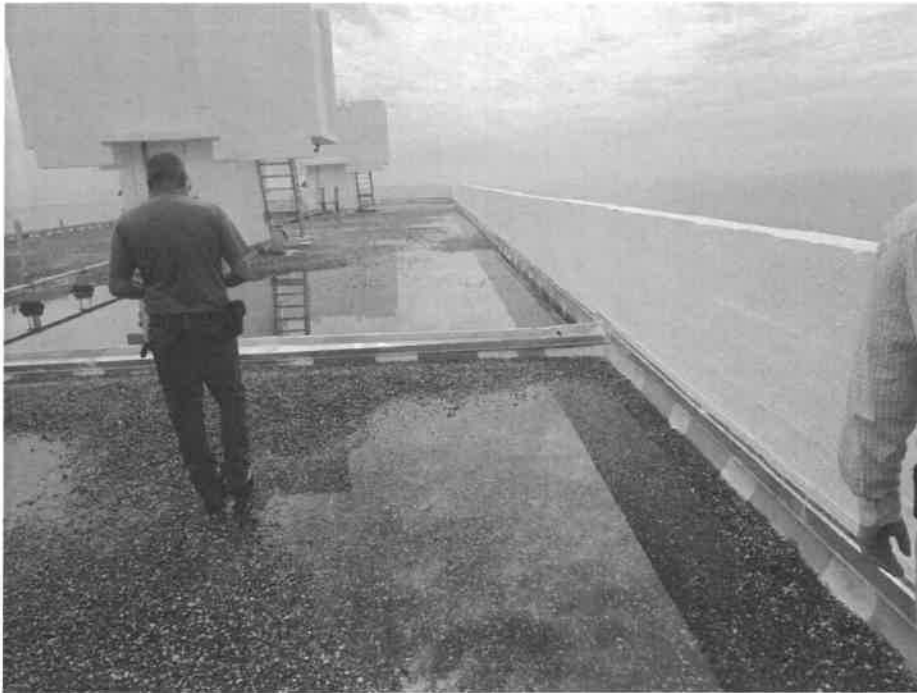
Photo at left depicts the elevator tower on the roof of the 28-story portion of the building, which is the east portion. This view is facing eastward.

No water leaks were evident and the roof appeared in good condition.

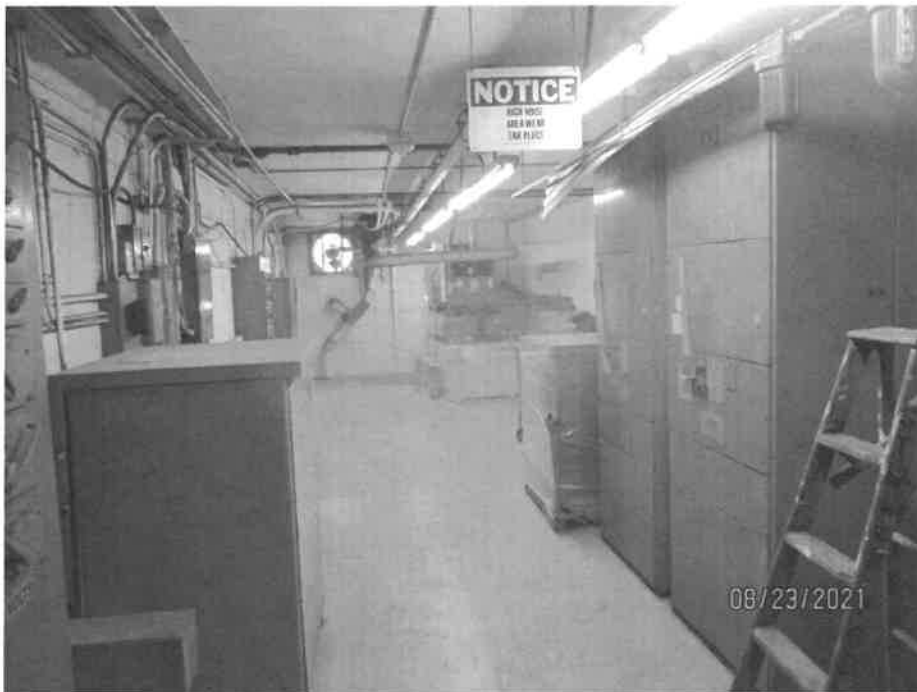
Photo at left depicts the electrical room in the lower portion of the building.

This room was found to be intact with no damages found.

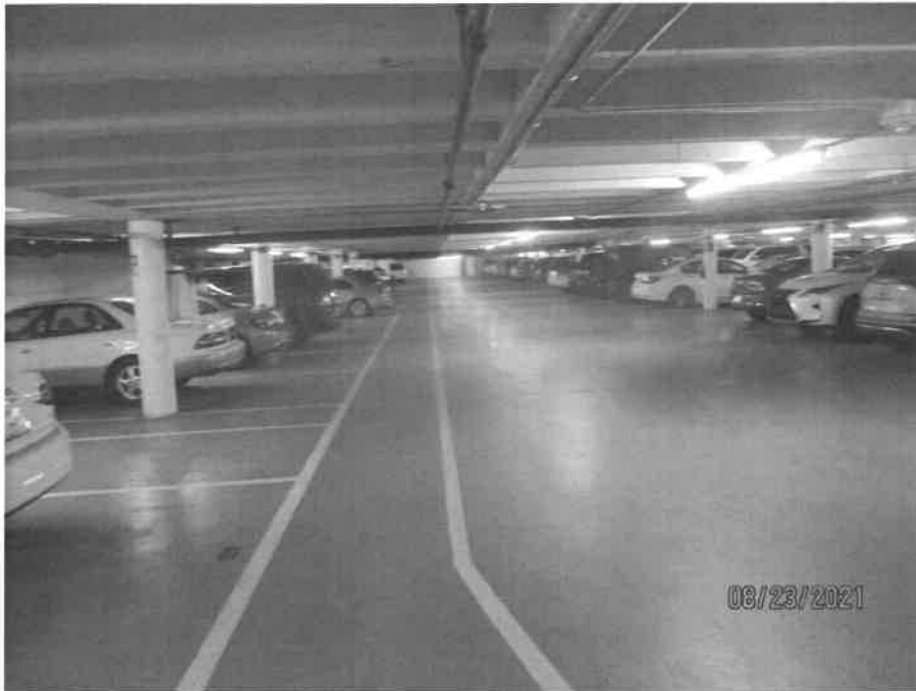
Photo at left depicts the lower parking garage area. There are structural damages, concrete spalling in the garage area, which must be repaired.

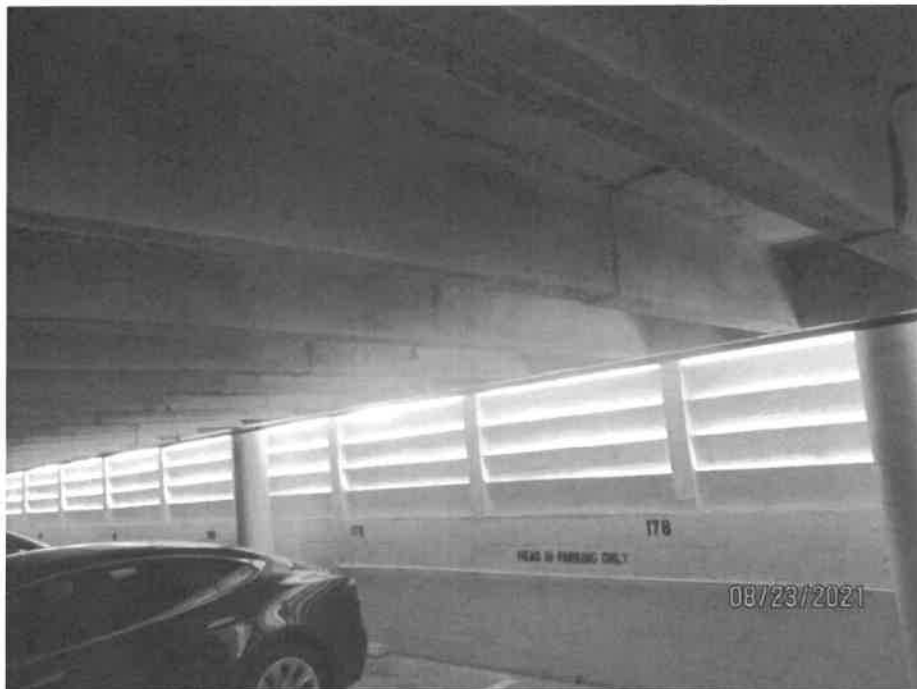
Photo at left depicts a section of the parking garage which was found to be in relatively good condition. There are still repairs to be completed in adjacent areas.

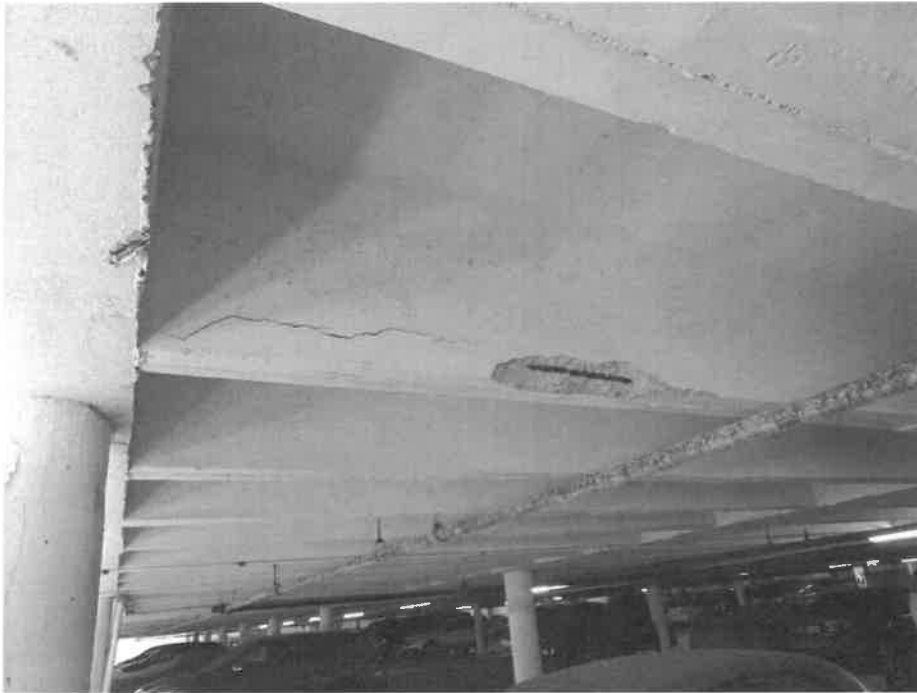
Photo at left depicts a section of the parking garage with concrete spalling that must be repaired.

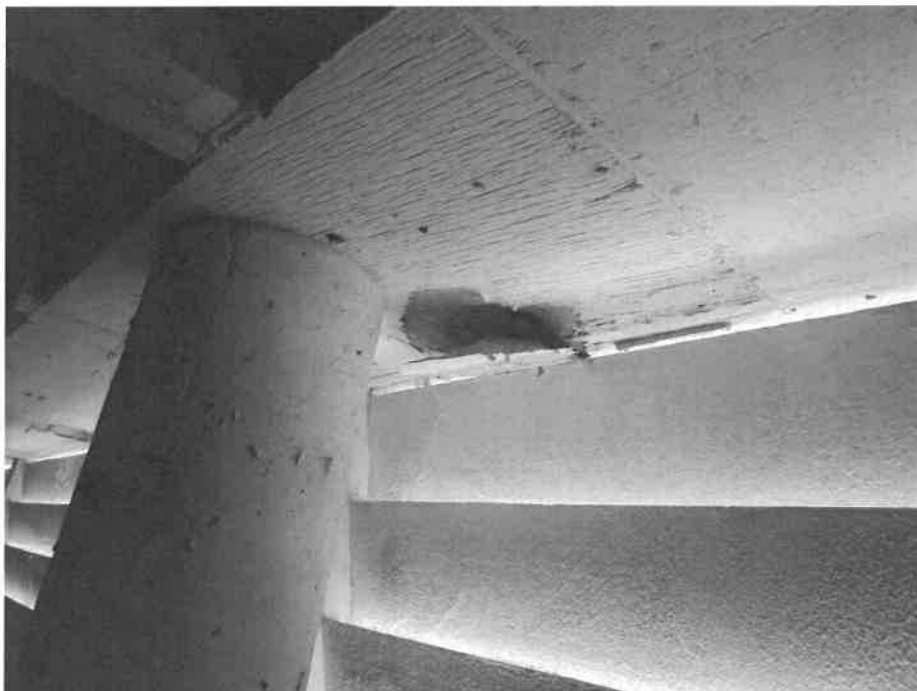
Photo at left depicts an OH soffit beam, located inside the garage, which is significantly spalled.

There are repairs required for these areas.

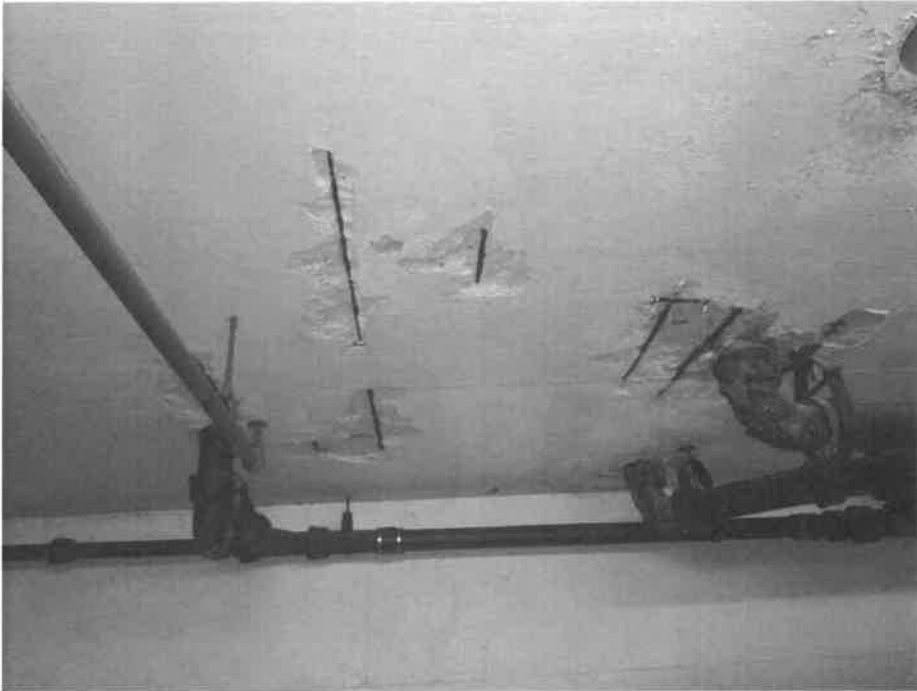
Photo at left depicts OH ceiling spalls in the lower portions of the building, which is spalled, which must be repaired.

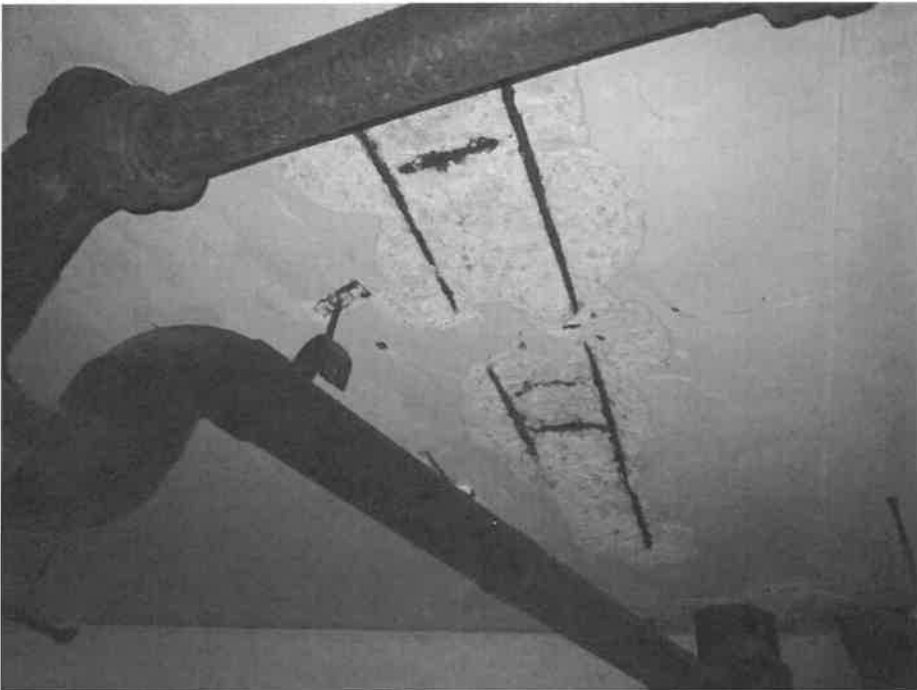
Photo at left depicts OH ceiling spalls in the lower portions of the building, which is spalled, which must be repaired.

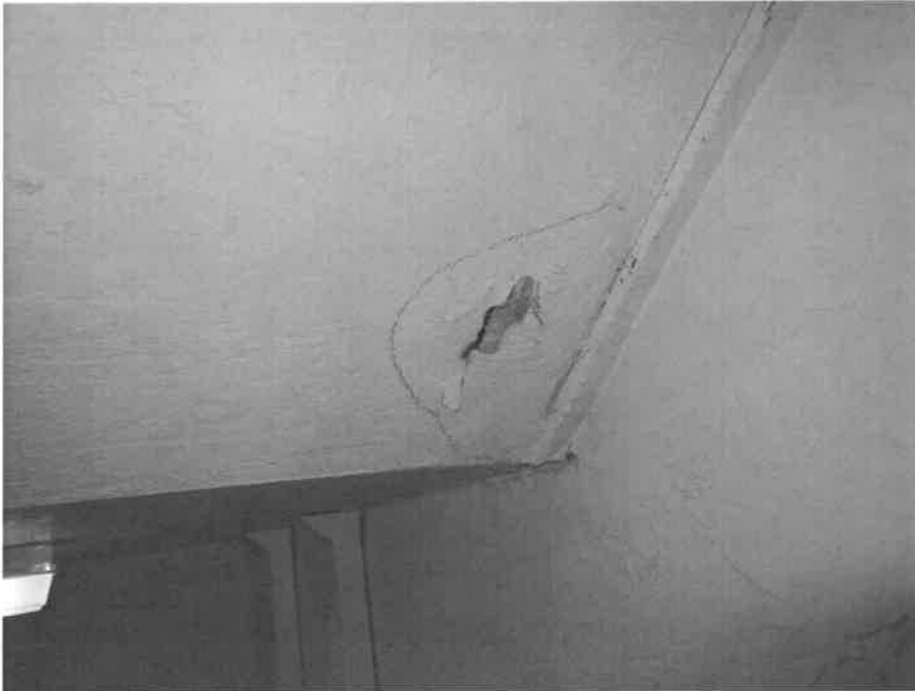
Photo at left depicts concrete spalling in the A/B stairwell. There are repairs required for these spalled areas.

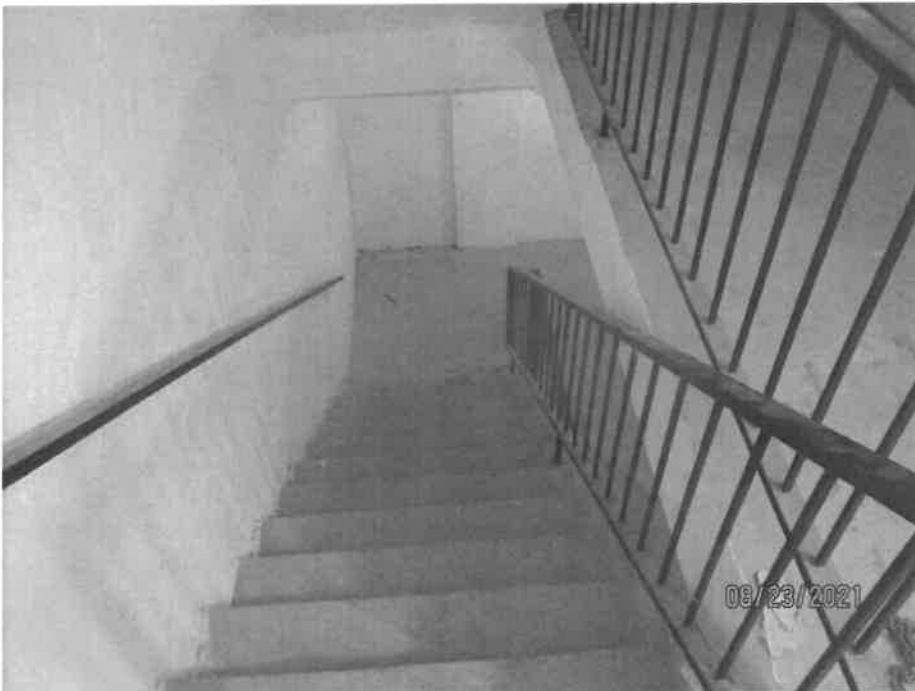
Photo at left depicts a typical stairwell with the hand rails and grab rails.

There are sporadic spalls in the various stair towers which must be repaired, but the majority of the stair towers are intact.

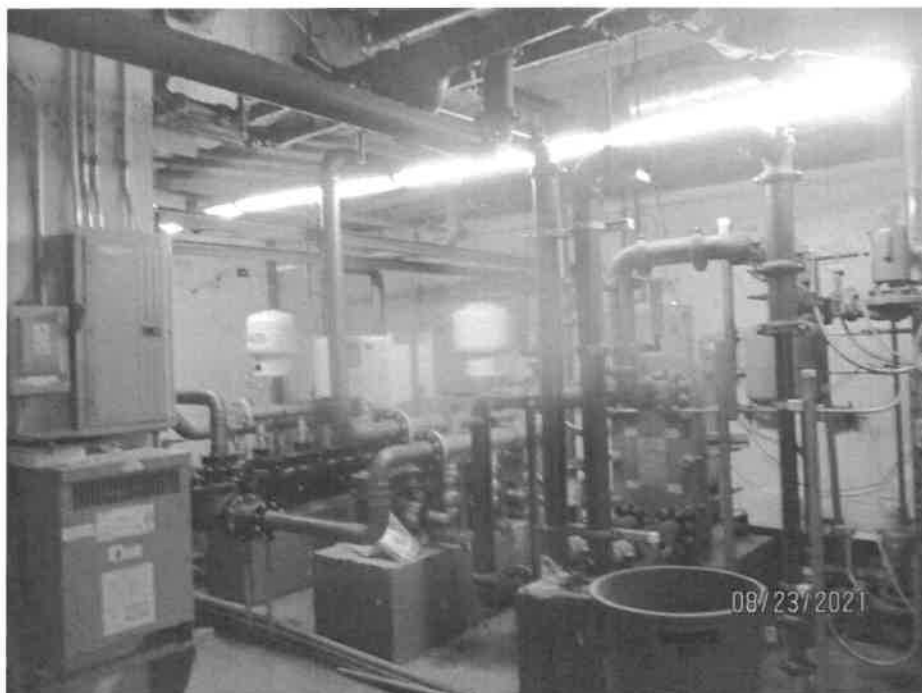
Photo at left depicts the mechanical room which was found to be intact, with no structural damages found.

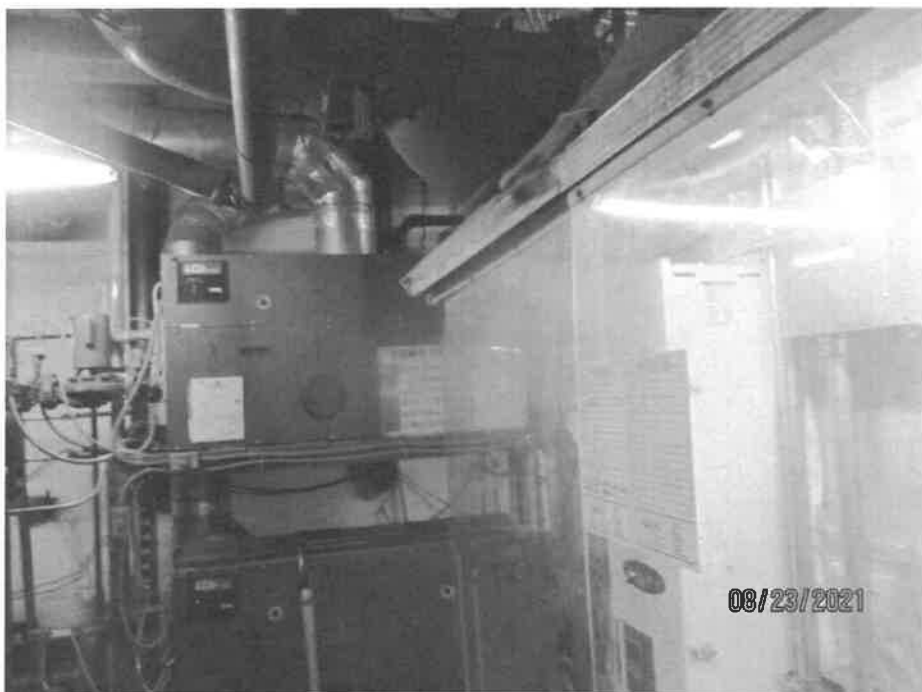
Photo at left depicts a mechanical room in the lower portion of the building, which was found to be intact with no structural damages found.

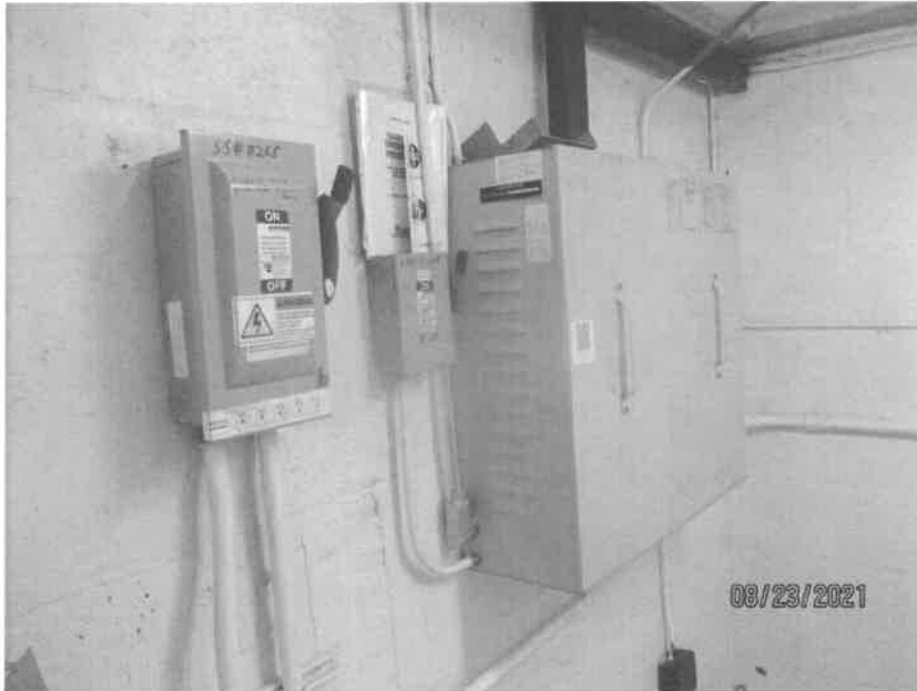
Photo at left depicts an electrical box, fastened to the wall in a lower room in the garage. The room was found to be intact, with no structural damages found.

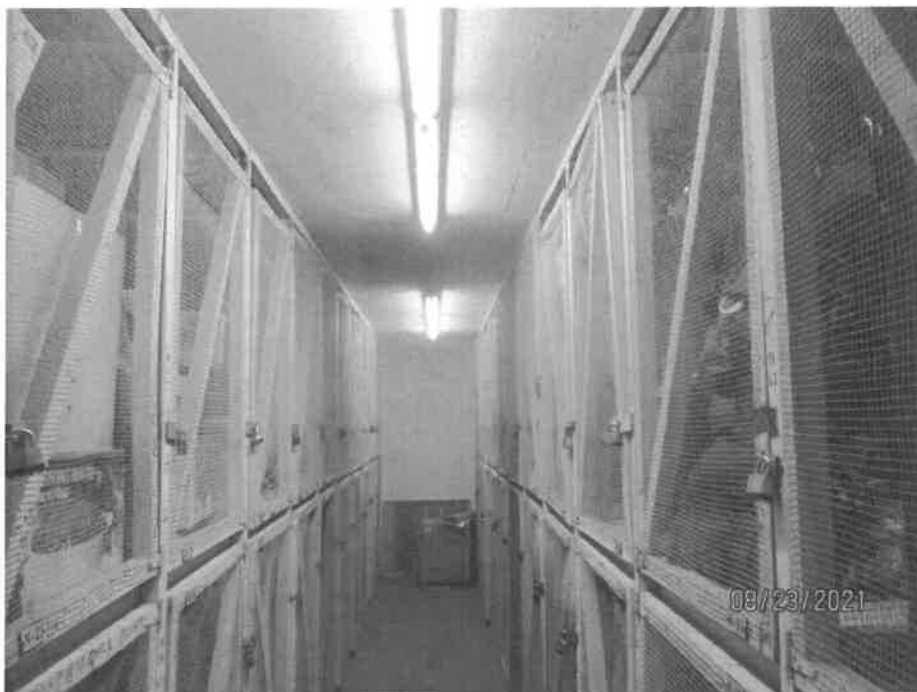
Photo at left depicts the storage room located in the garage near the pool pump room, which was found to be intact, with no structural damages found.

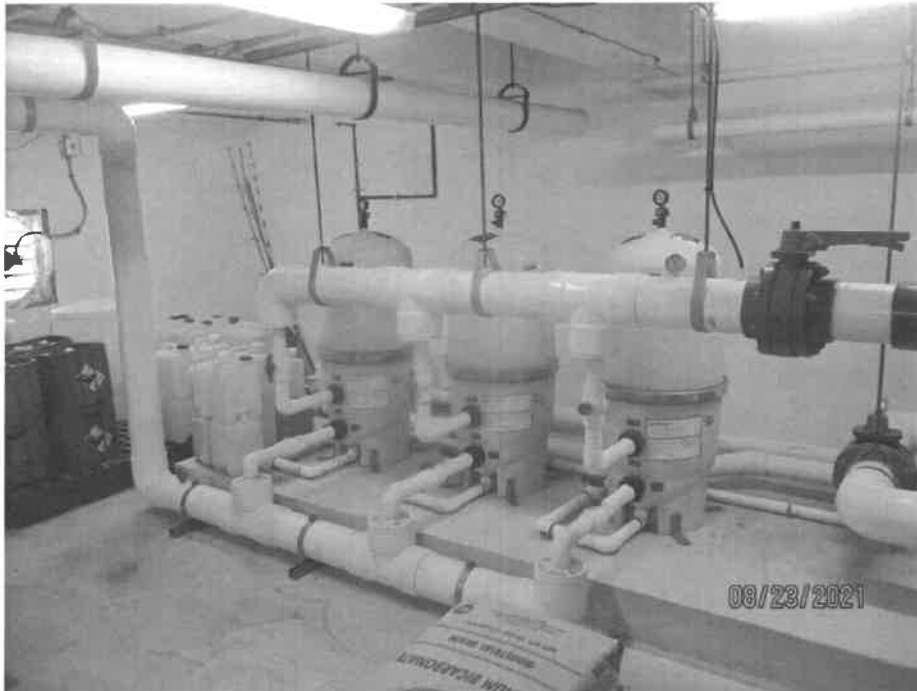
Photo at left depicts the pool pump room which is intact, with no structural damages found.

There is an epoxy floor membrane, which protects the concrete elements in this room.

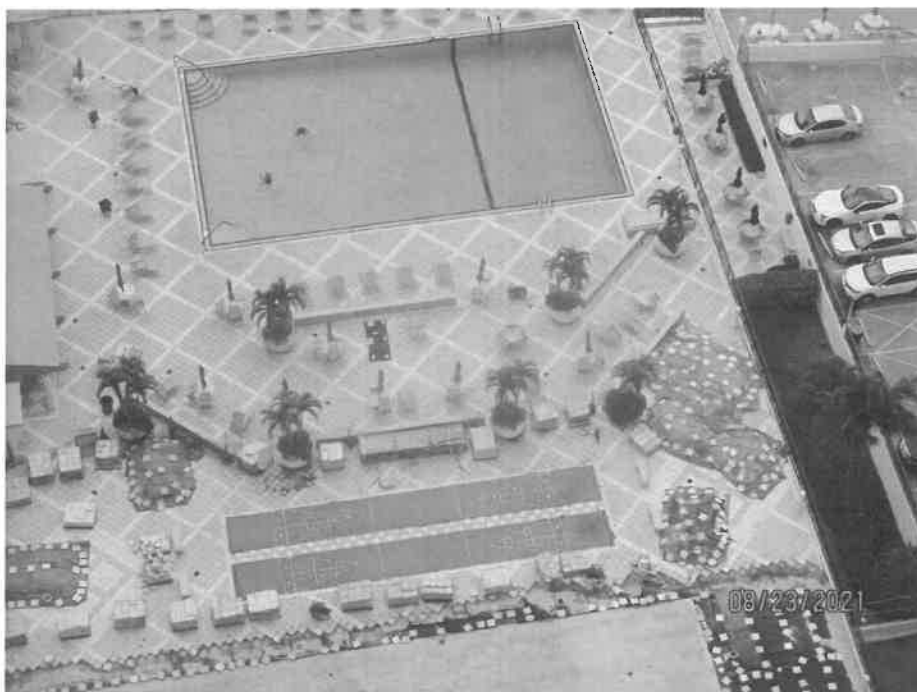
Photo at left depicts the East deck portion of the recreation deck surrounding the swimming pool. This portion was found to be intact and in good condition.

The west portion of the Recreation deck has been stripped and the spalled slab areas have been chipped and poured back.

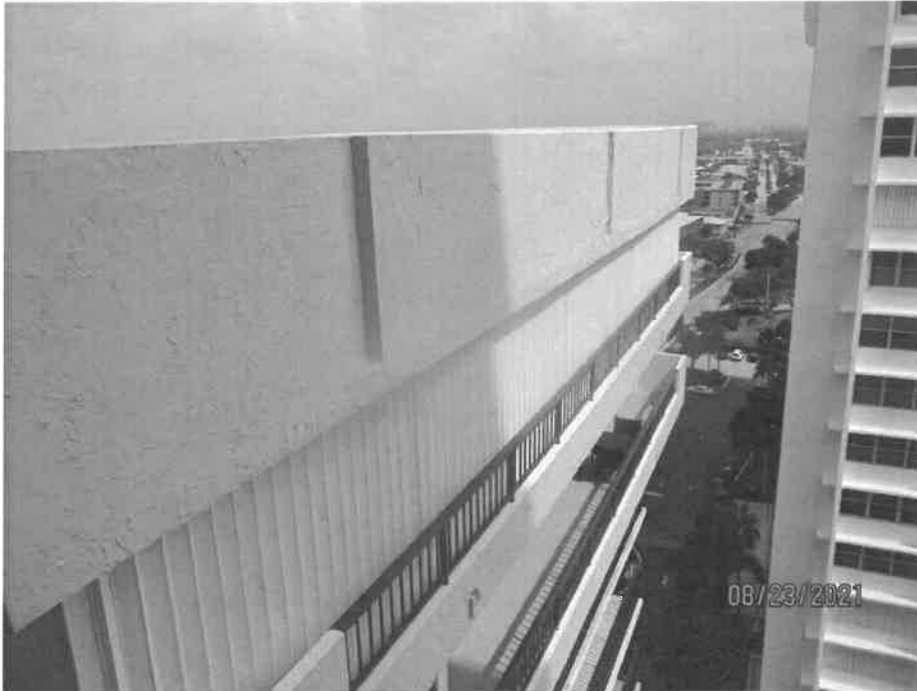
Photo at left depicts the outer edge of the PH balcony, with the balcony railings, shutters and roof parapet. These elements are in good condition.

This portion of the building is the 16-story area, located at the north end.

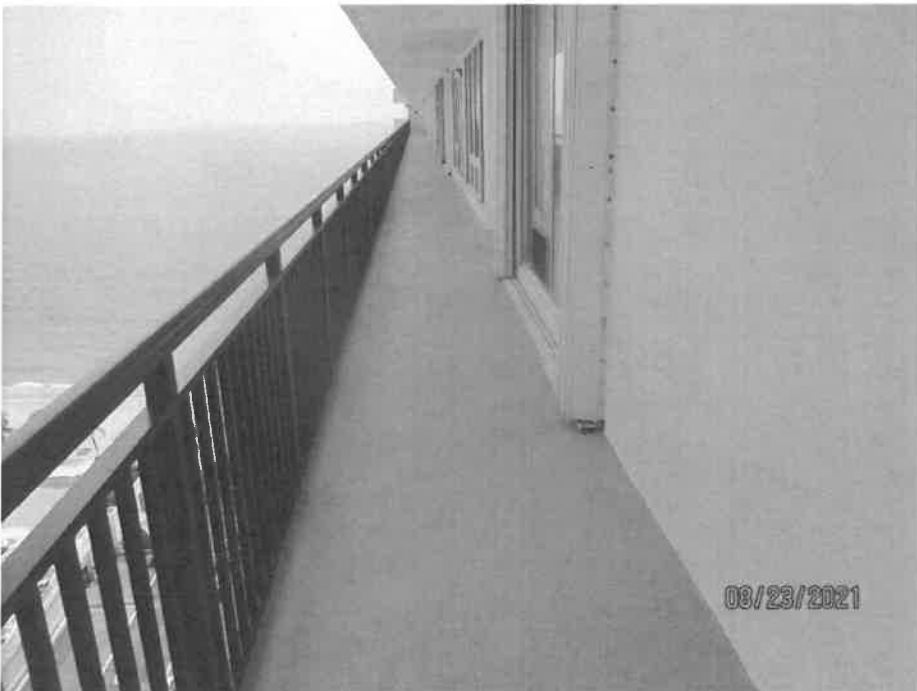
Photo at left depicts the North elevation catwalks that were found to be in good condition with no structural issues found.

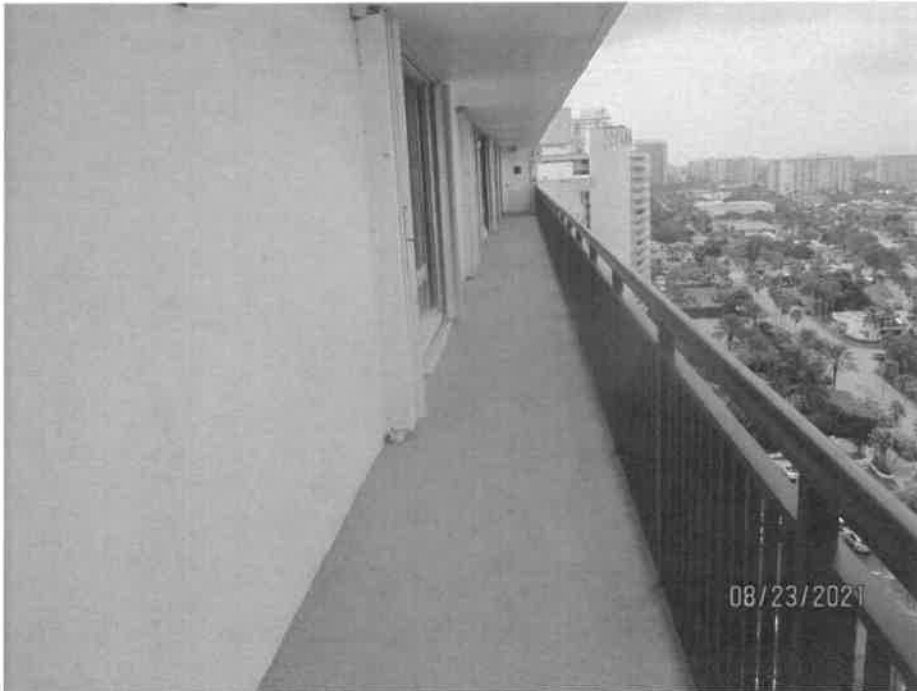
Photo at left depicts the West elevation catwalks that were found to be in good condition with no structural issues found.

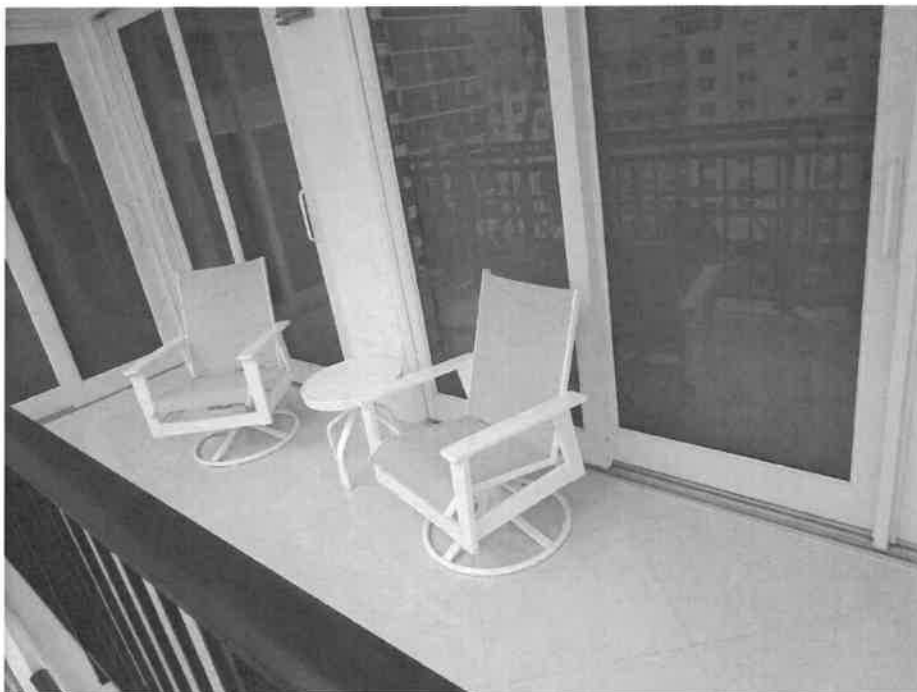
Photo at left depicts a balcony slab with recently installed SGD's, which were found to be impact resistant SGD's. This balcony was found to be intact with no structural damages found.

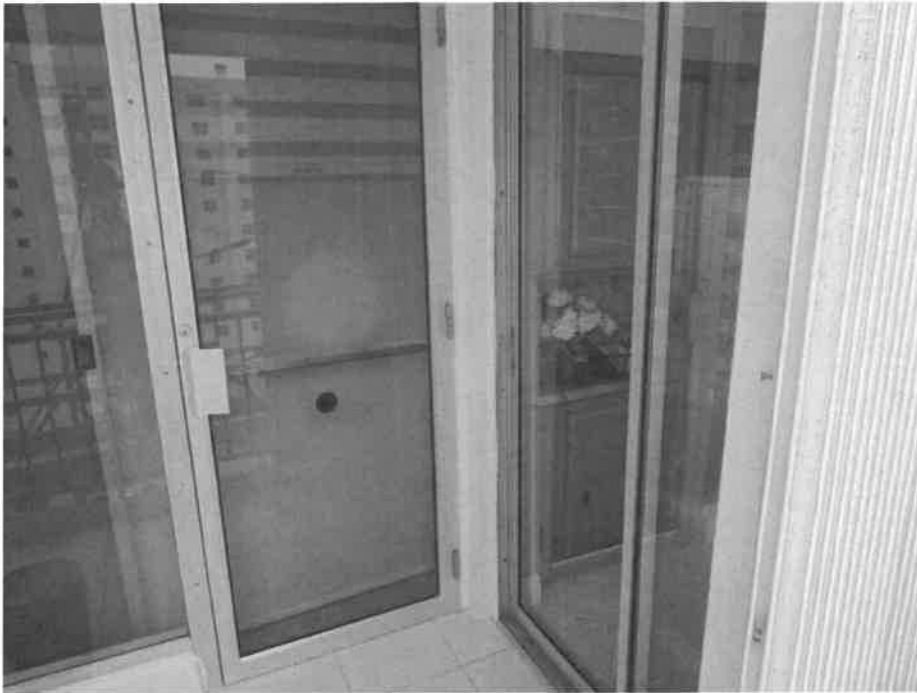
Photo at left depicts a balcony with the original SGD, at left, with an original swing door, center. There are shutters on this balcony to cover these non-impact rated elements.

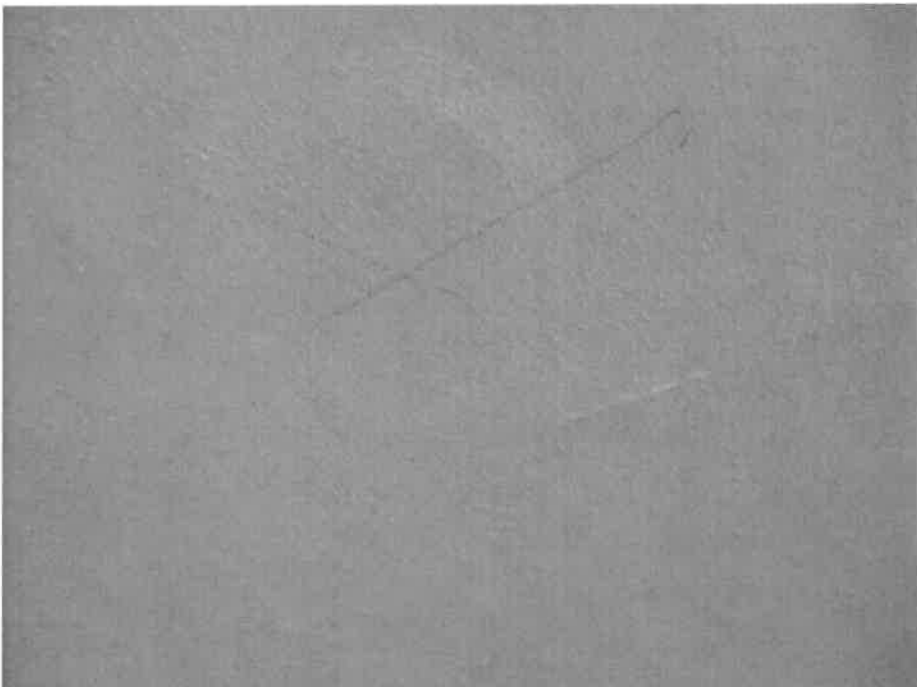
Photo at left depicts a balcony ceiling spall that is need of repair. There are a number of spalls, on various balconies, which require repairs for these affected areas.

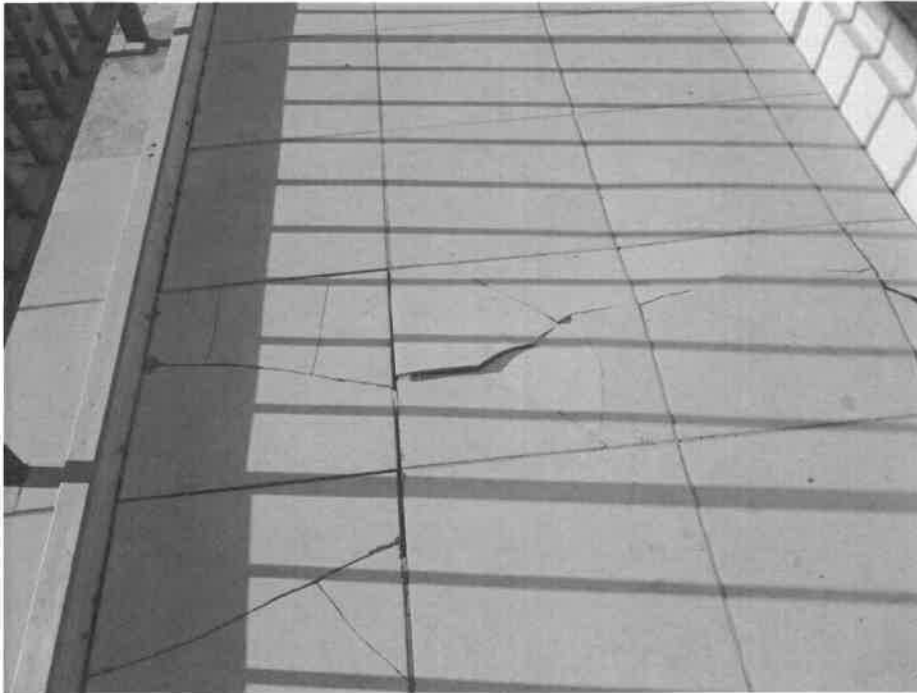
Photo at left depicts a balcony with existing floor tiles that have "heaved" and are breaking.

There are repairs required for these areas.

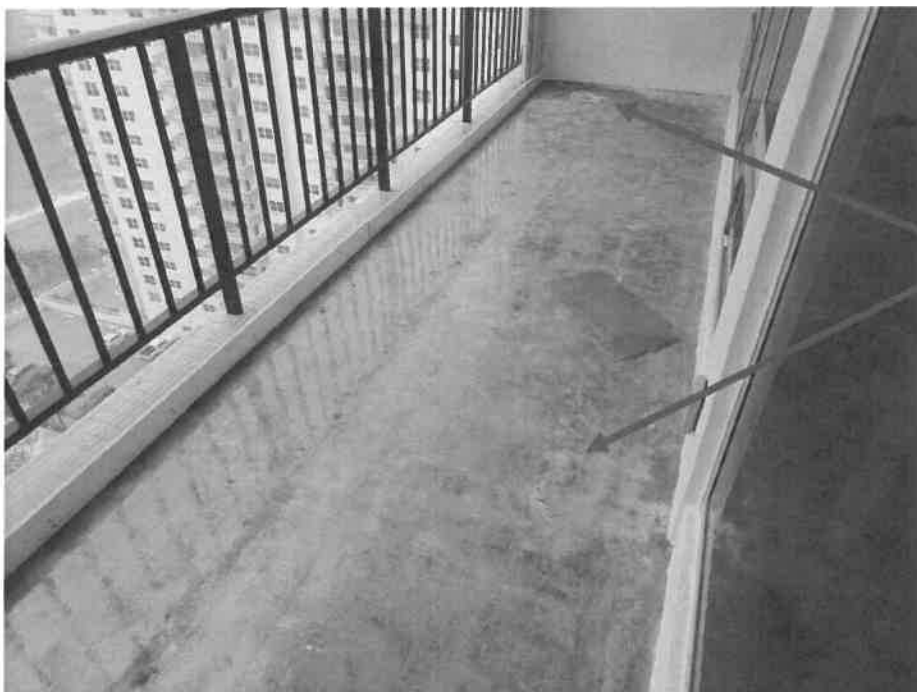
Photo at left depicts the balcony slab that has no waterproofing and has a number of spalled concrete areas.

There are repairs required for these areas.

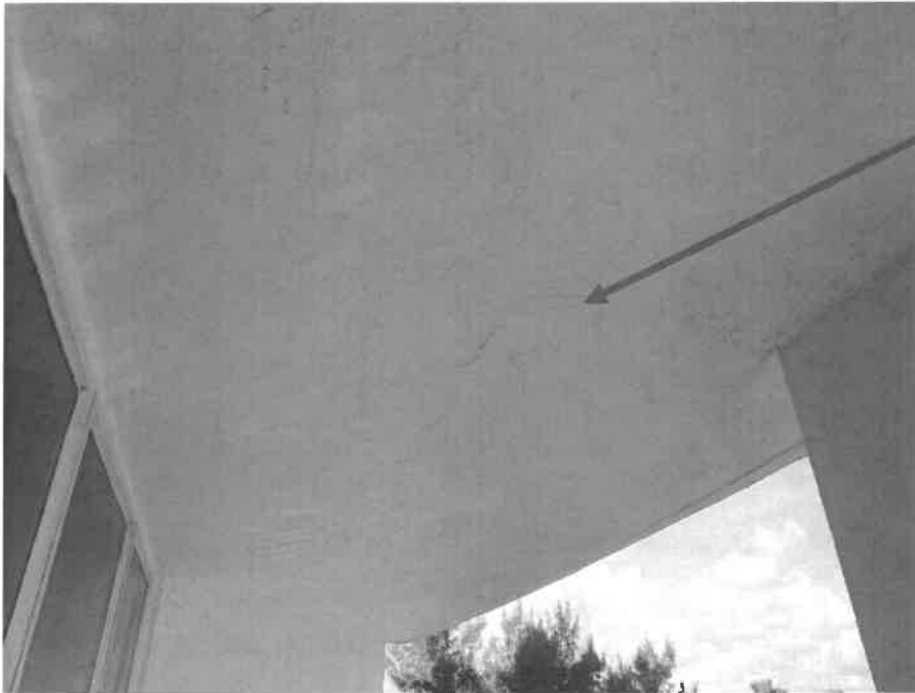
Photo at left depicts the balcony ceiling concrete that is spalled and in need of repair.

There are repairs required for these areas.

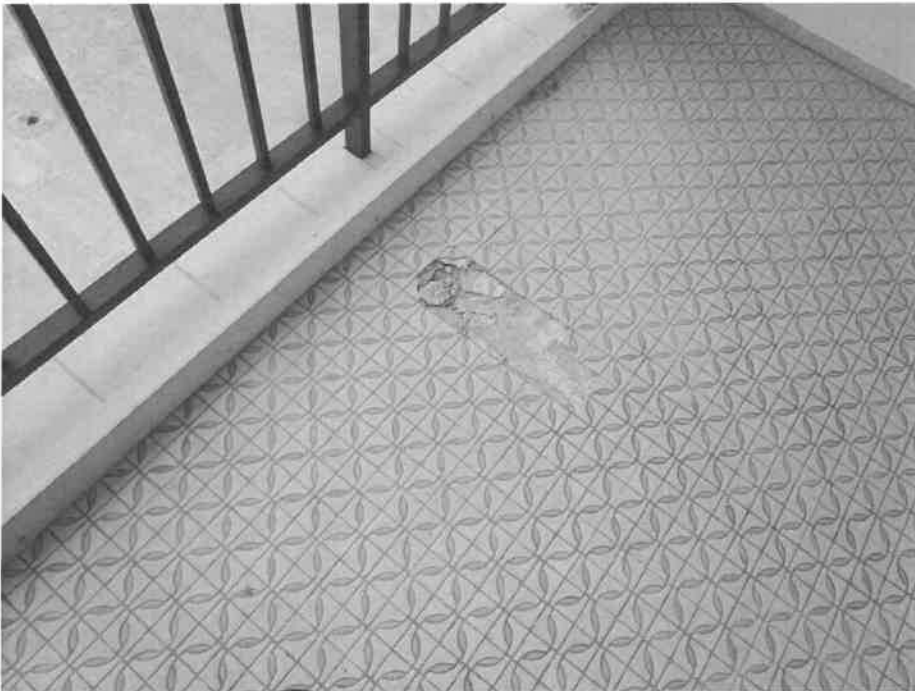
Photo at left depicts the balcony which has a concrete spall which has caused the floor tiles to lift and break.

There are repairs required for these areas.

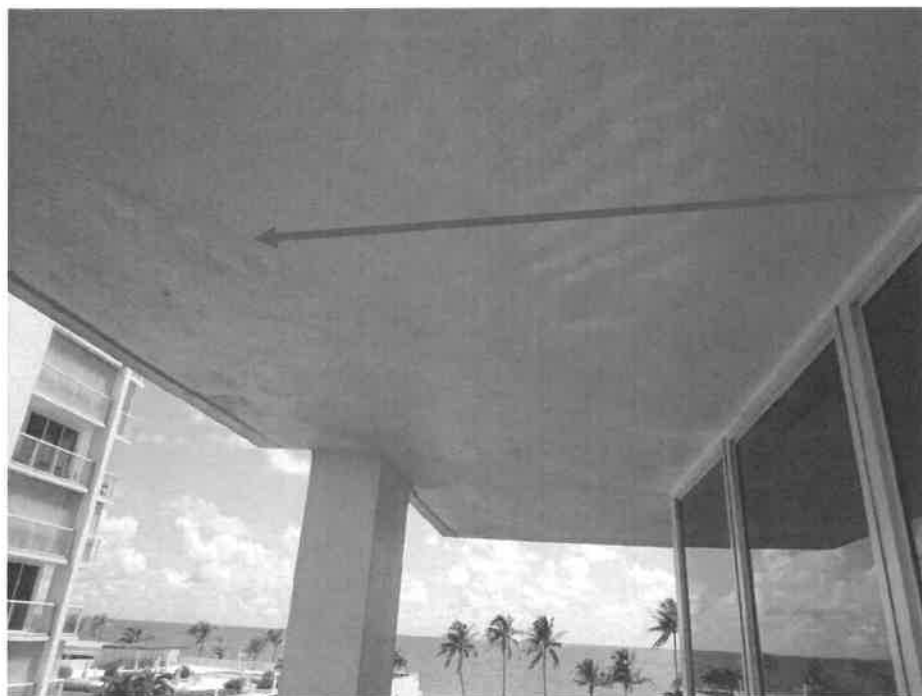
Photo at left depicts the balcony ceiling that has concrete spalls that are in need of repairs.

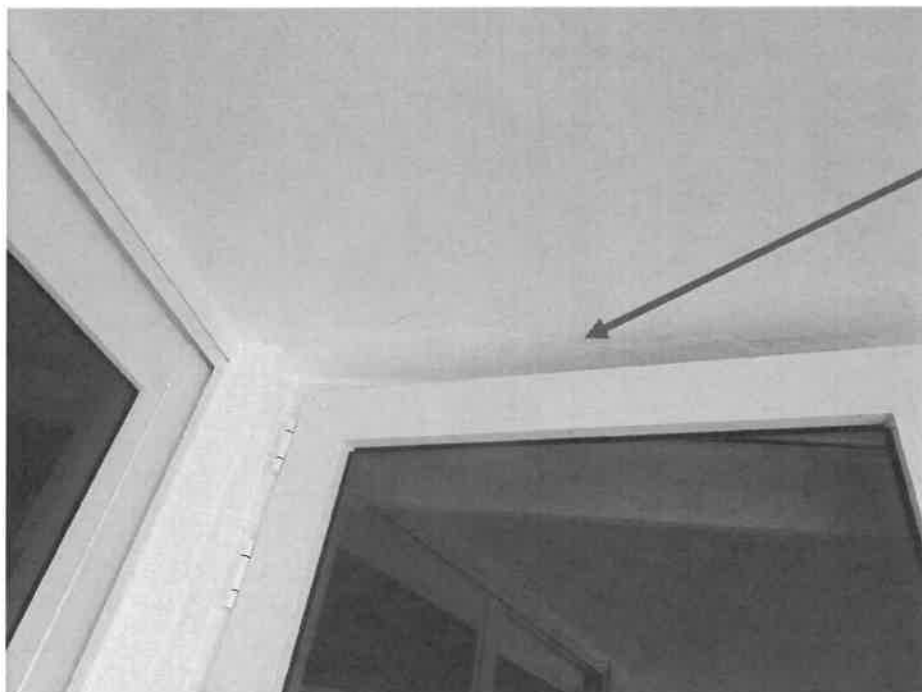
Photo at left depicts the balcony ceiling above the kitchen door that is spalling, and in need of concrete repairs.

The swing door and adjacent SGD was found to have impact-resistant glass.

The concrete structure in this area will require repairs.
