Building Safety Inspection Report Form Amended 03/15/12
STRUCTURAL

Building / Structure address Plaza South Condominium
 Legal description 494319AM0010 Plaza South Condo Common Area 335 Units 494319AM0010 thru 494319AM3360
 Folio # of Building /Structure 494319AM0000
 Owner's name Plaza South Condominium Common Area 335 Units
 Owner's mailing address 4280 GALT OCEAN DRIVE, Ft. Laud., FL

Inspection Firm or Individual BROMLEY COOK ENGINEERING INC.
 Address 5440 NW 33 AVE SUITE 100, FT. LAUD., FL 33309
 Phone 954-772-4624

Inspection Commencement Date 08/23/21 Inspection Completion Date 09/ 17/ 21
 Inspection made by David Dolbee

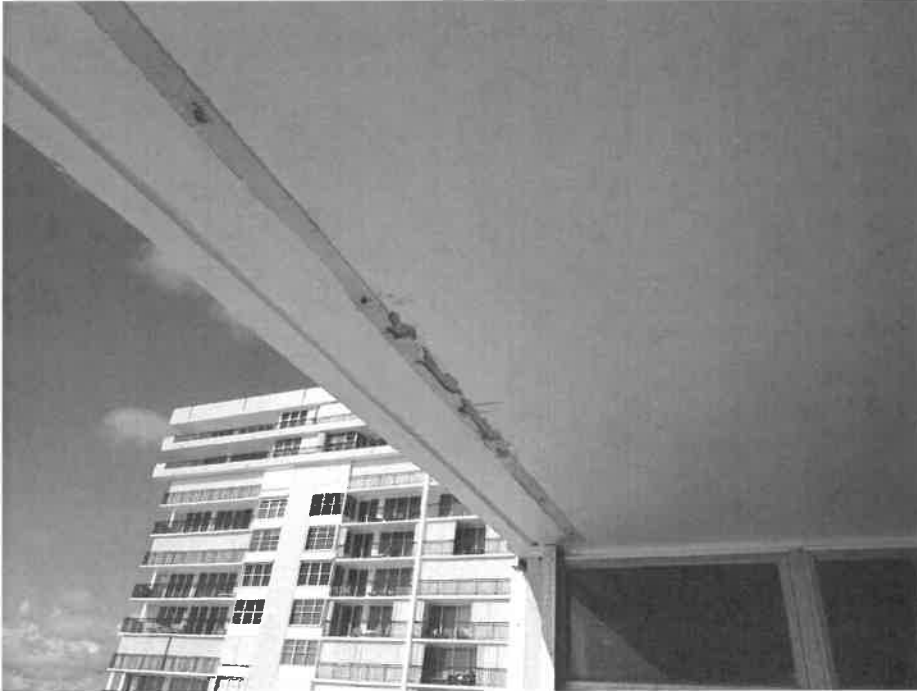
Photo at left depicts the balcony ceiling where a shutter track was removed and not repaired.

There are repairs required for these types of areas.

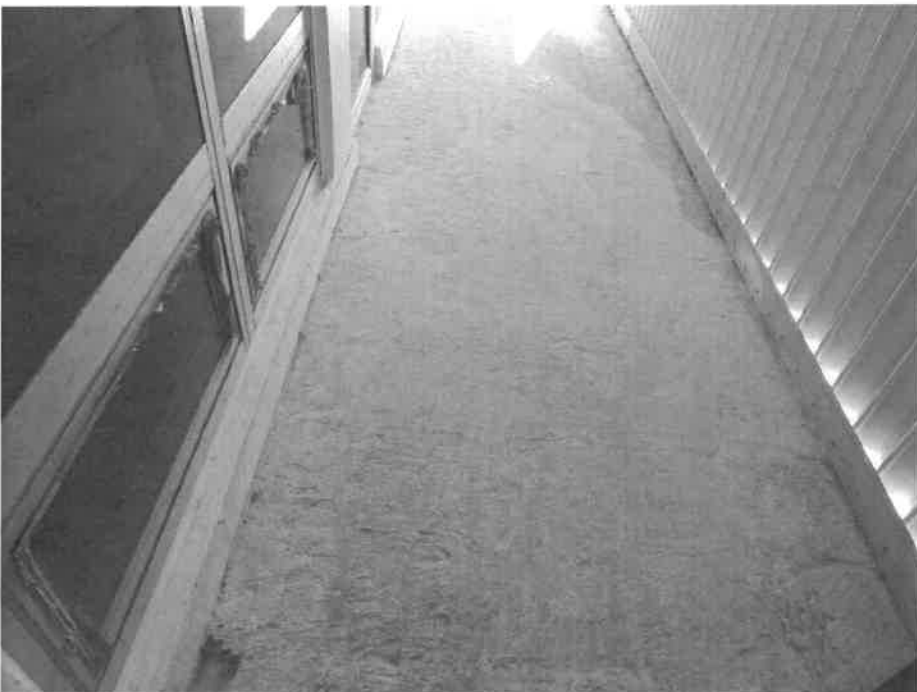
Photo at left depicts a balcony slab that was stripped to bare concrete and not refinished.

The spalled concrete in these areas will require repairs and the balcony slab must be waterproofed for long term protection.

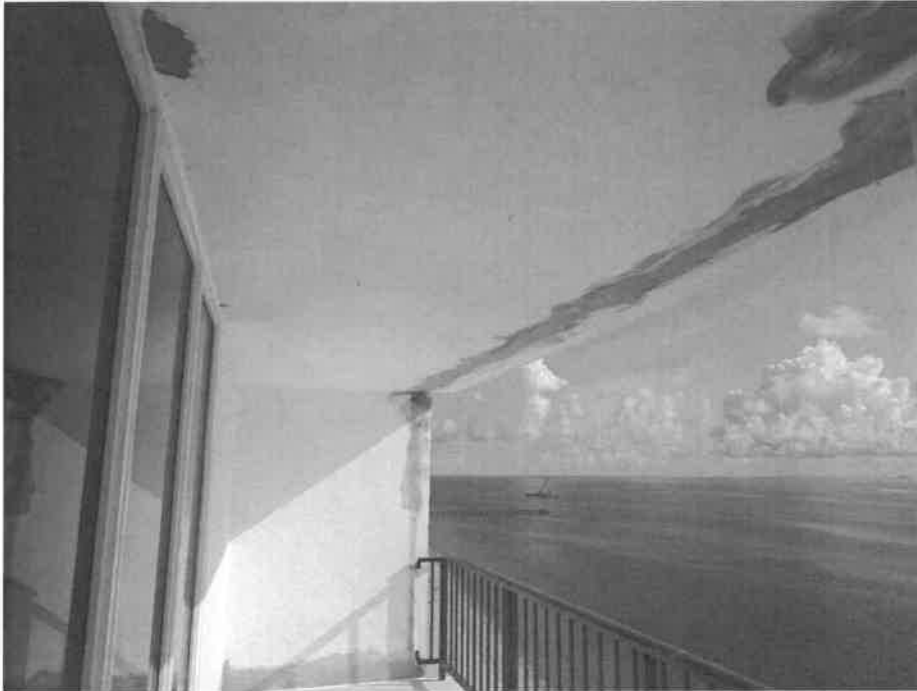
Photo at left depicts the balcony ceiling where a shutter track was removed.

Any remaining spalls must be completed, new stucco applied, then the surfaces must be painted.
