ELECTRICAL SAFETY INSPECTION REPORT FORM

a. Name on Title:	<u>Plaza South</u>	
b. Street Address:	<u>4280 Galt Ocean Dr, Ft. Lauderdale FL 33308</u>	
c. Legal Description:	<u>see structural report</u>	
d. Owner's Name:	<u>see structural report</u>	
e. Owner's Mailing Address:	<u>see structural report</u>	
f. Folio Number of Property on which Building is Located:	<u>see structural report</u>	
g. Building Code Occupancy Classification:	<u>see structural report</u>	
h. Present Use:	<u>see structural report</u>	
i. General Description, Type of Construction:	<u>see structural</u> Square Footage:	Number of Stories:
j. Special Features:		
k. Additional Comments:

Building: Plaza South

Address: 4280 Galt Ocean Dr, Ft Lauderdale Fl 33308

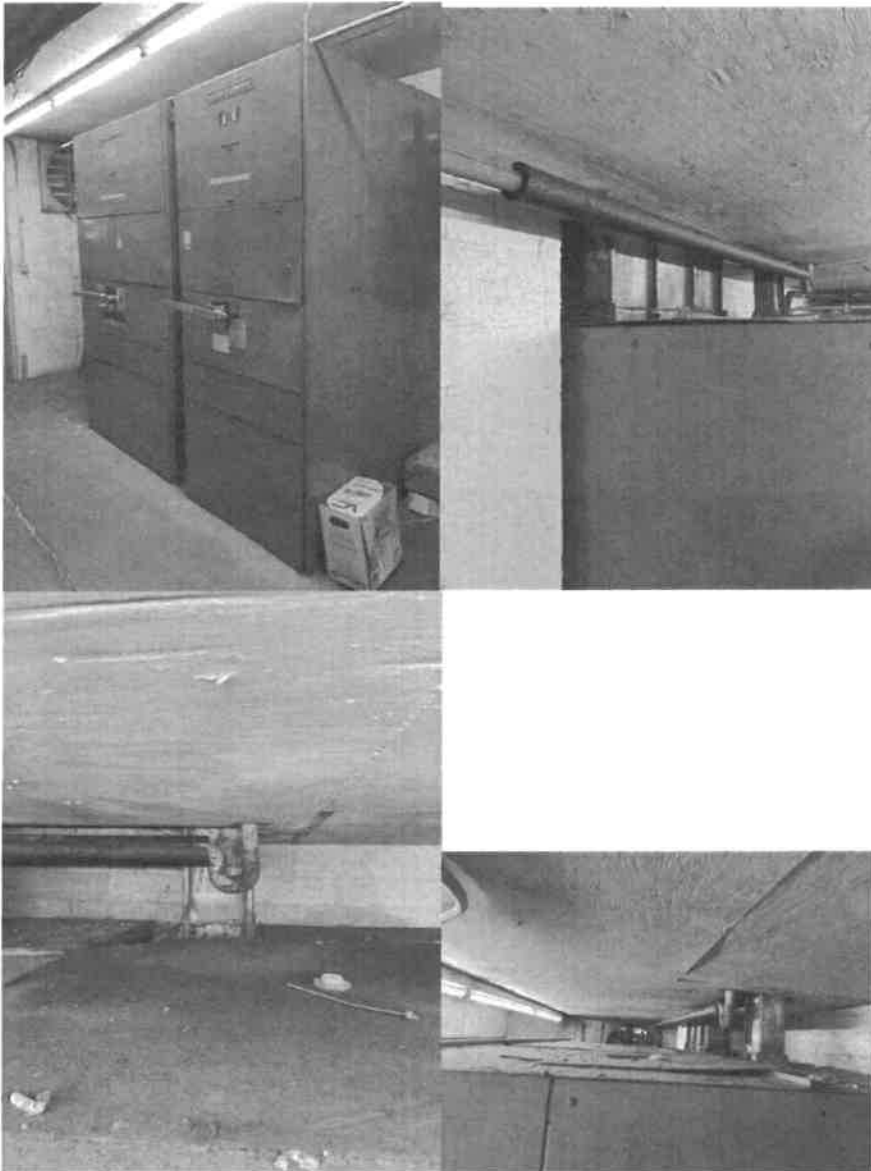
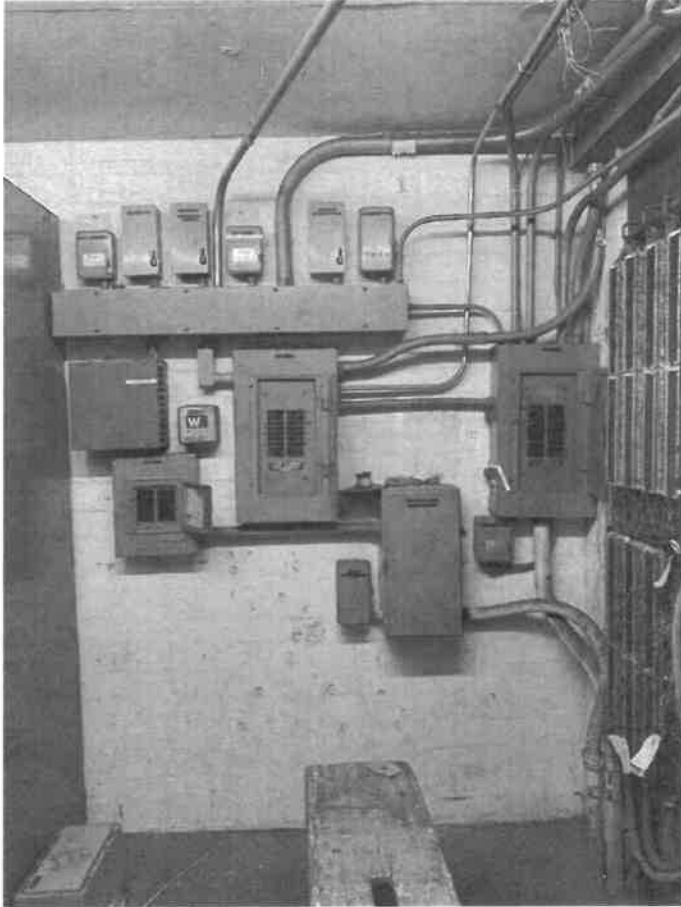
Comments:
Mains: 4000A,2500A,2000A,1600A.
Main electrical room have sanitary and condensate lines over the service disconnects (mains) which are leaking and corroding the switchgear. Refer to pictures at the end of report.

Main service disconnects for apartments meter centers are under a sanitary drain. Disconnects must be protected with an aluminum lid (pan) from leaks.

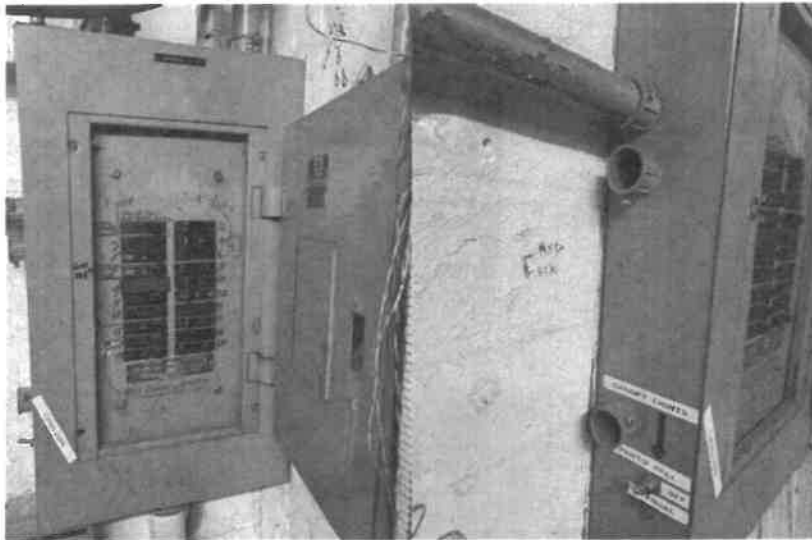
Open knock outs must be covered with a listed cover. Switch must be removed. Branch circuits must be identified on placard.

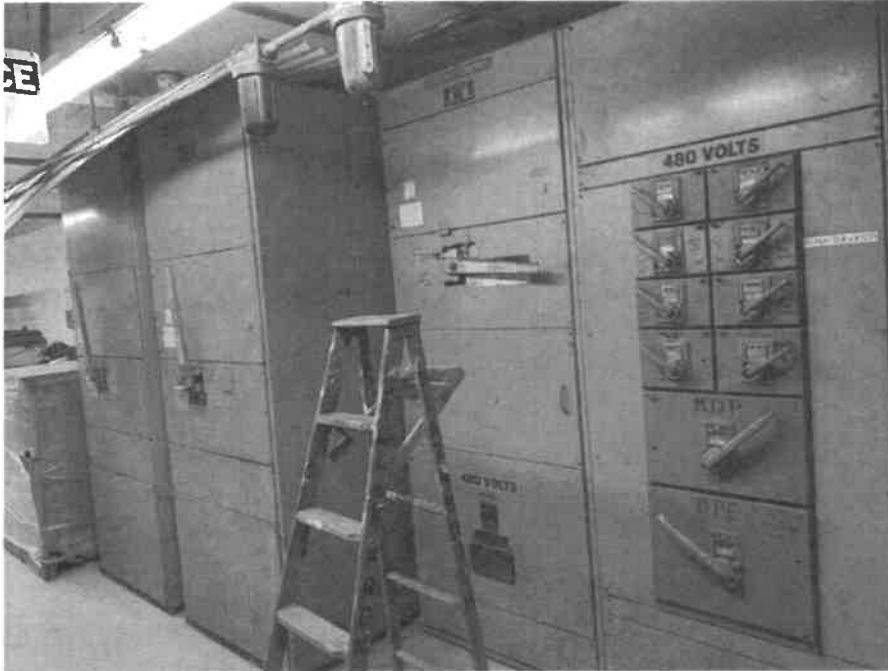
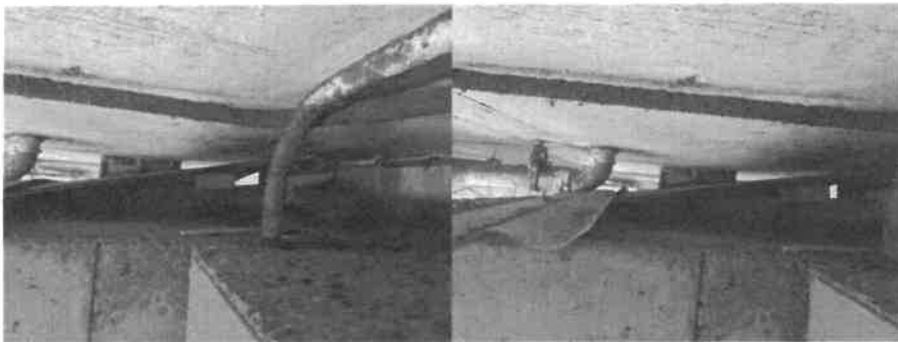
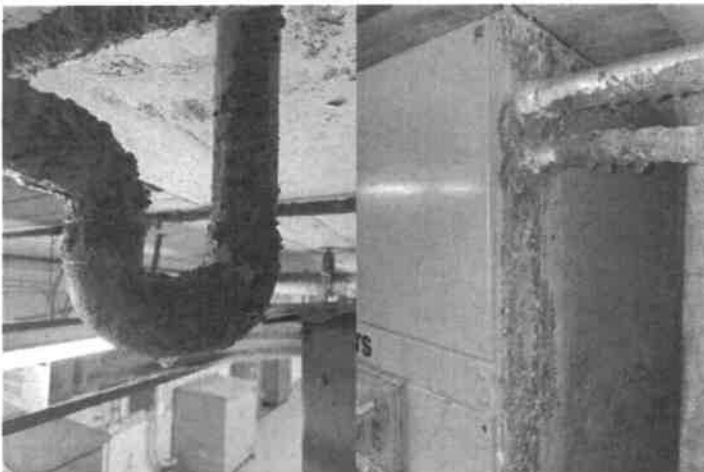
Main electrical room switch gear has severe corrosion due to plumbing leaks. Pan (lid) must be provided with drain over electrical equipment.

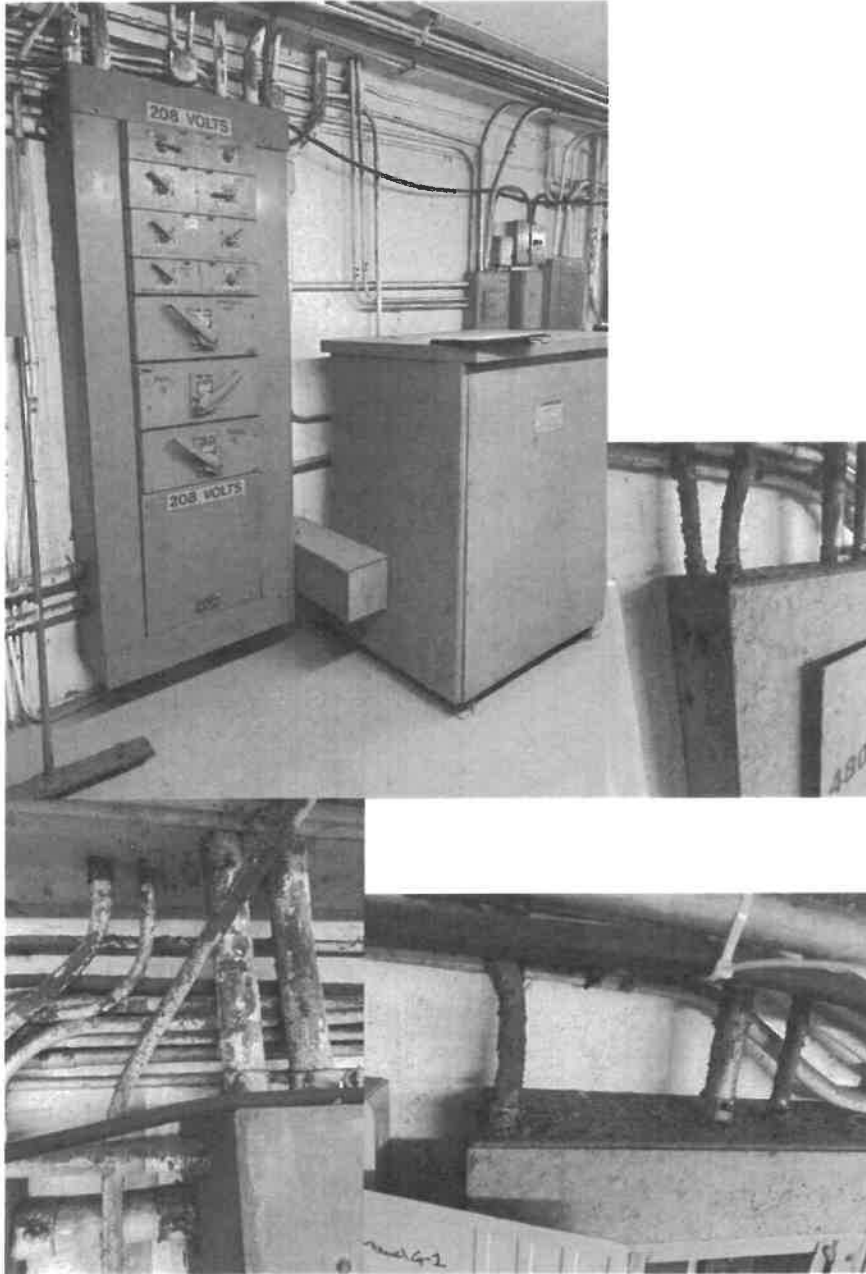
1. Panel #(AC) Generator and main electrical room, requires labels, rust, and opening, refer to pictures.

Conduits have severe corrosion that must be removed. Conduits must prime and painted. If the conduits are perforated, they must be replaced. 480v panel has open knock outs and severe corrosion.

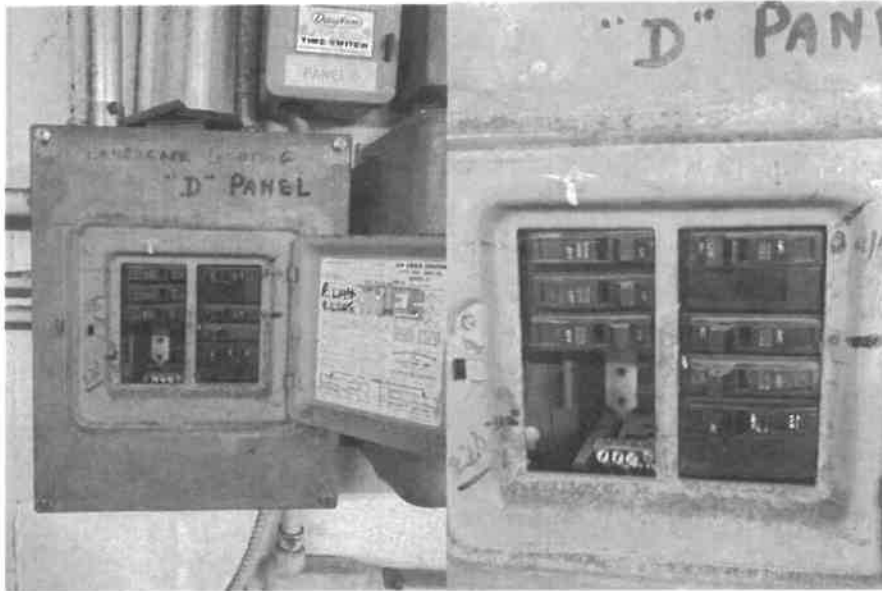
2. Panel #(D) Open branch circuit positions require UL covers, see pictures.

Panel D has open breaker position that must be covered with a UL listed cover. Panel requires priming and painting.

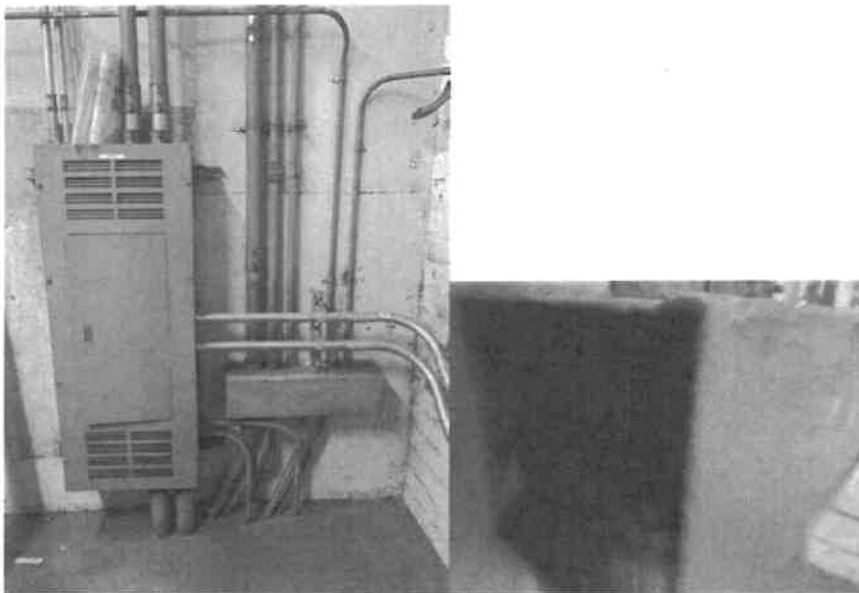
Comments:
Pump room wire way requires cover.

Wire way in pump room is missing end cover.

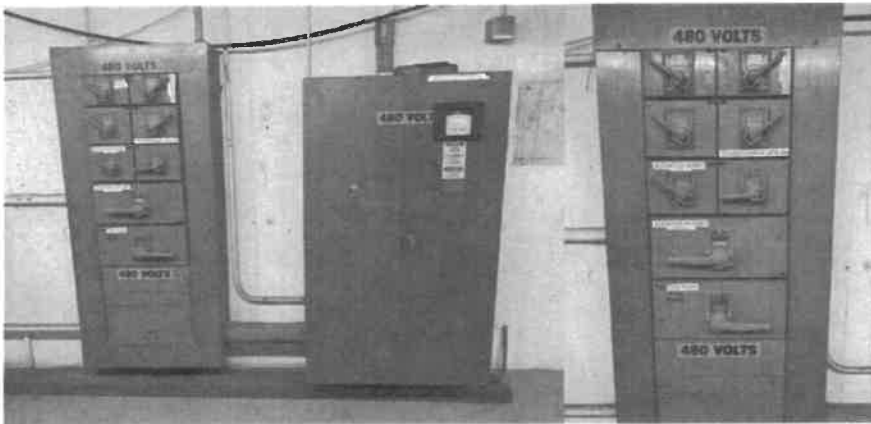
Booster pumps cannot be connected to emergency system. Fire pump feeder cannot have over current protection.

Building booster pump (top right disconnect) cannot be connected to the emergency panel. Must be relocated to a normal power panel.

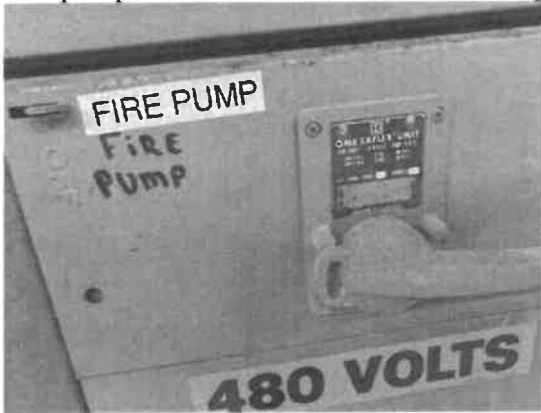
Fire pump feeder cannot have over current protection.

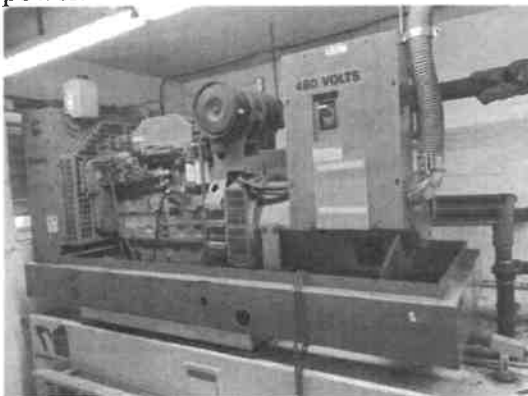
Emergency generator is rated for 175 KW/219 KVA at 3 ph, seems underrated for 75 hp fire pump and emergency load. Recommend doing a load study and load test with fire pump under load on emergency power.

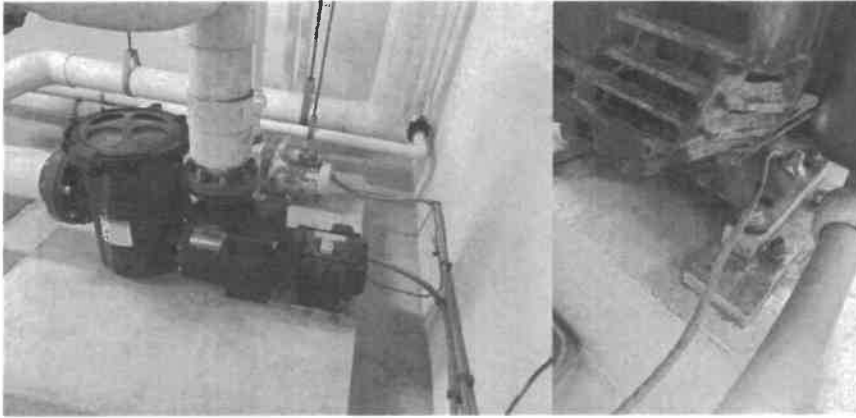
Pool bonding system must be connected to pool pump grounding lug and all mechanical equipment in the pool room (per NEC 680). Contractor shall test bonding system and provide engineer with ohm readings of all metallic fixtures in contact with the pool water.

Pool bond must be tested to be connected to all metallic ladders and fixtures in contact with the pool water.

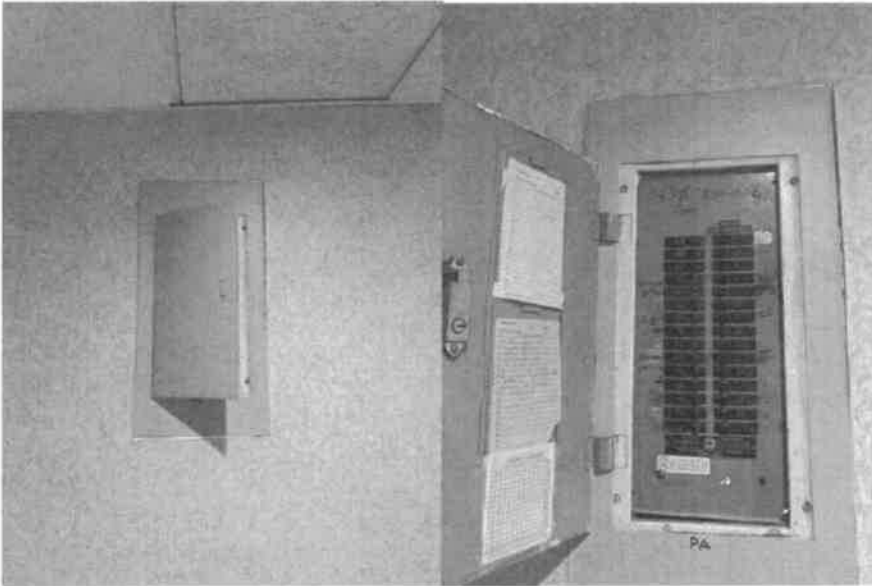
Corridor building panels must be under management control. Recommended installing a lock with key on all corridor panels.

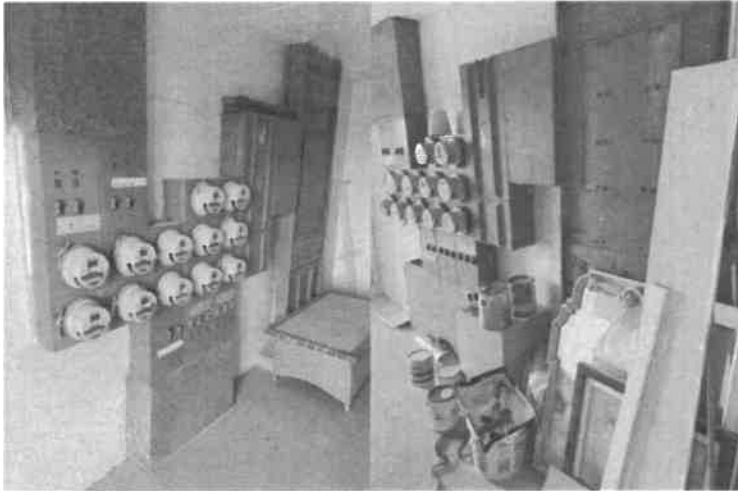
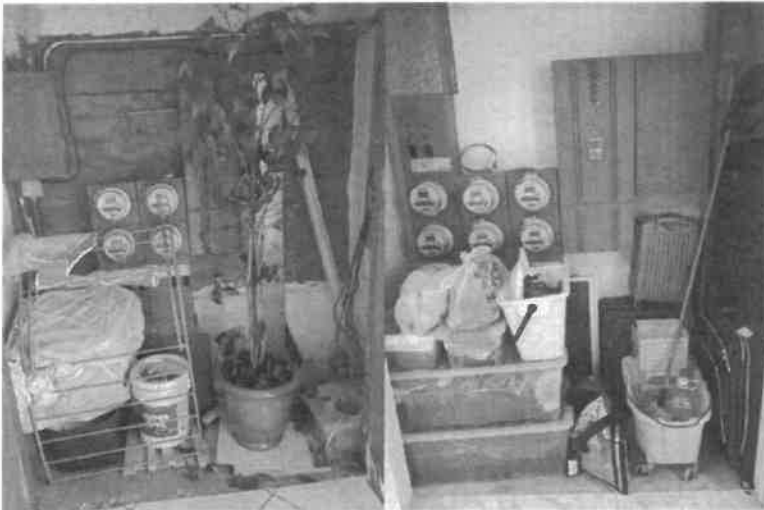
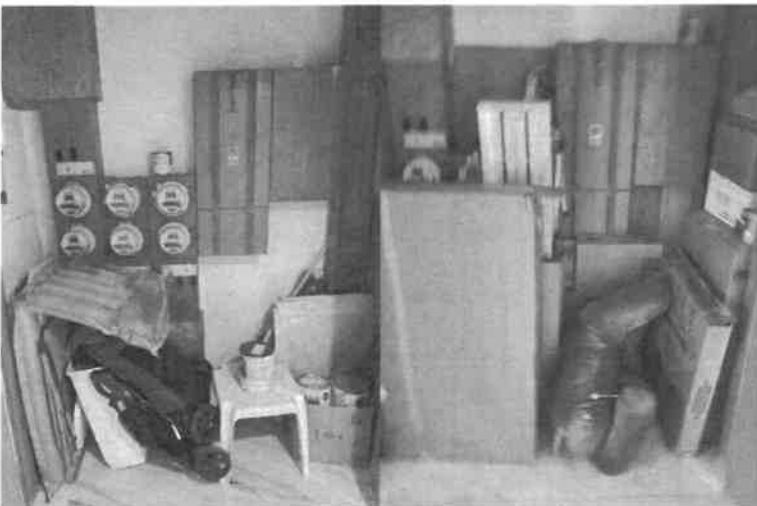
Comments:
Some of the meter center rooms are being used for storage, refer to pictures at the end of this report.

No storage is permitted in electrical rooms.

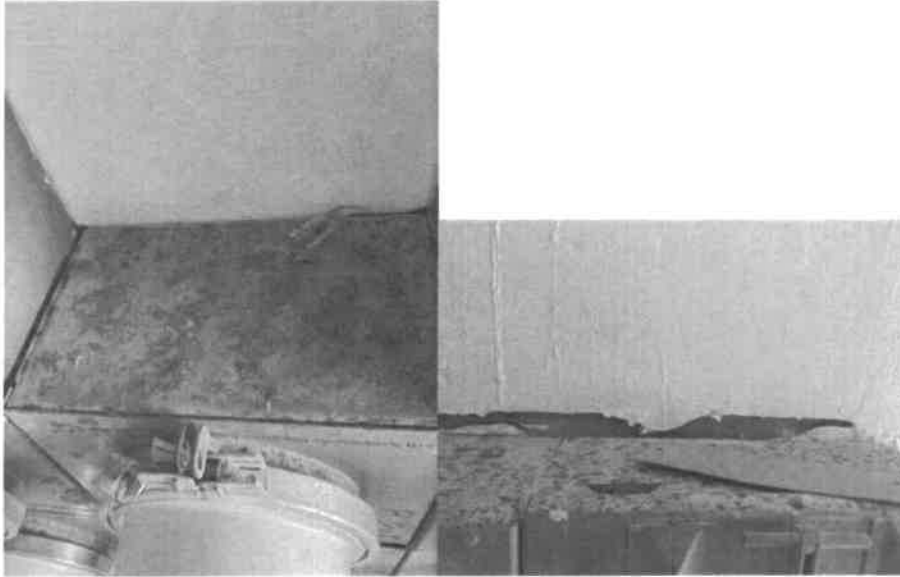
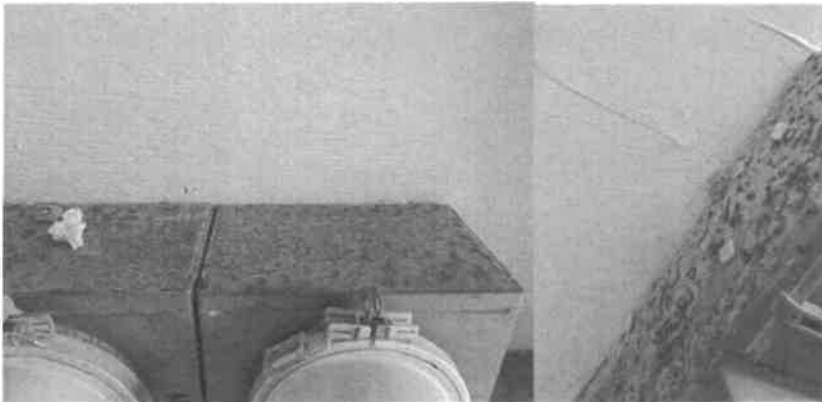
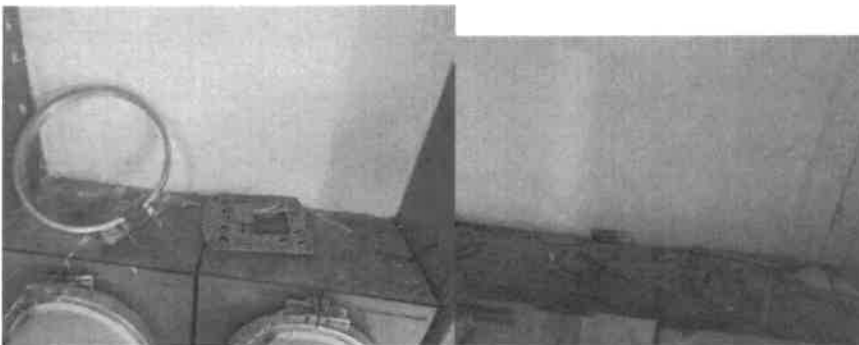
Tenant meter centers require rust to be removed and prime and painted.

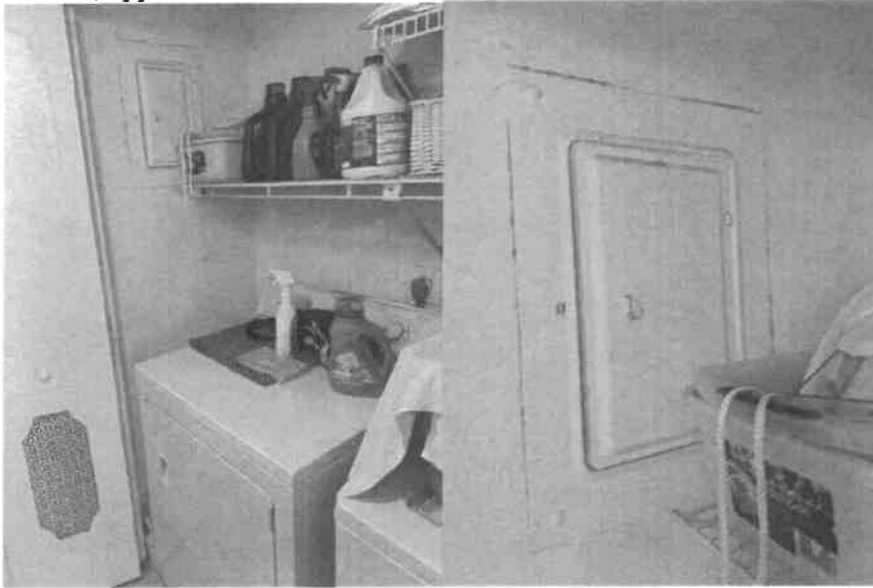
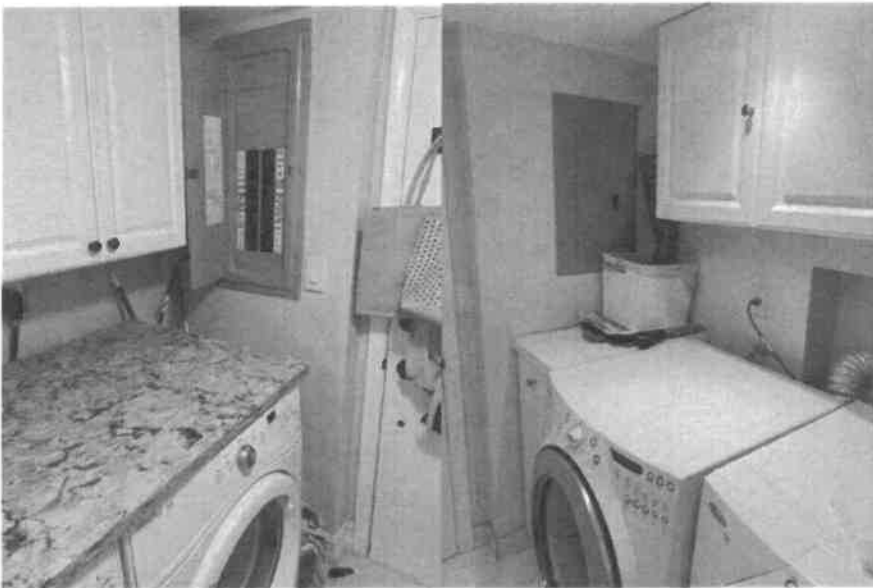
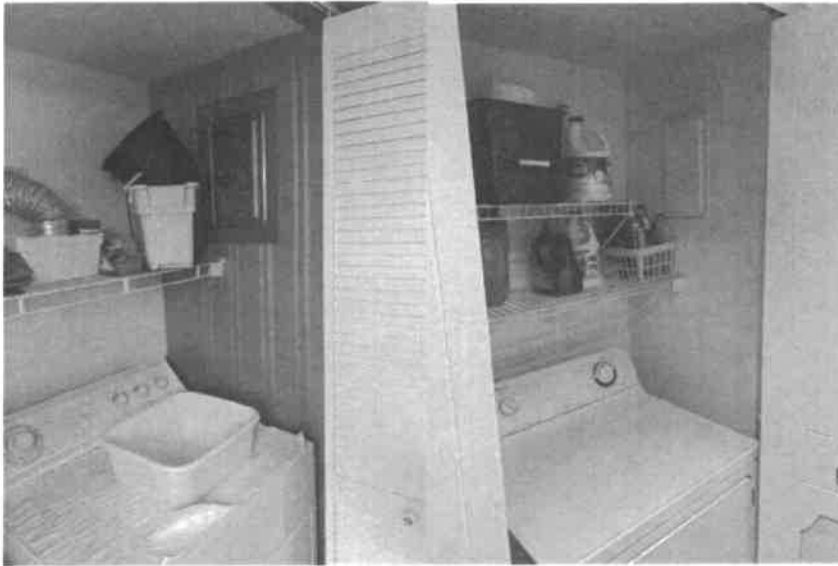
Unit electrical panels must be readily available, cannot be blocked by shelves, appliances etc.

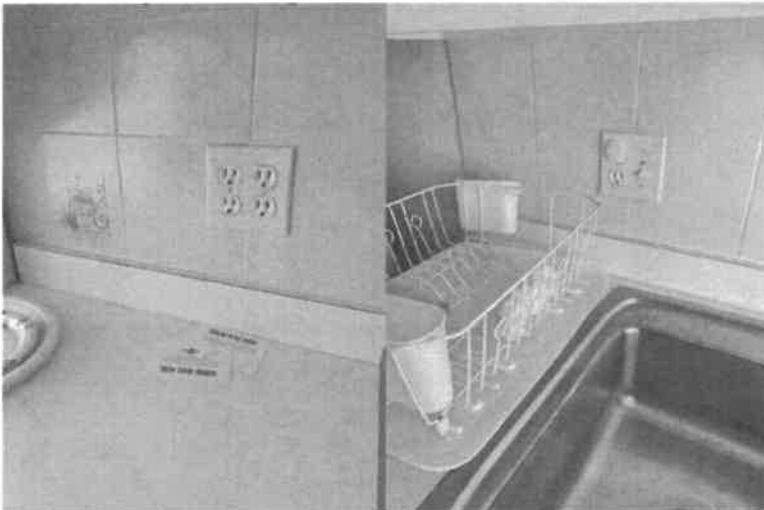
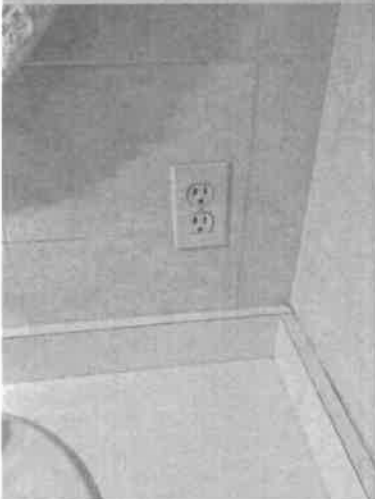
Kitchen and bathroom receptacles must be GFCI type.
