Building Safety Inspection Report Form Amended 03/15/12
STRUCTURAL

Building / Structure address Plaza South Condominium
 Legal description 494319AM0010 Plaza South Condo Common Area 335 Units 494319AM0010 thru 494319AM3360
 Folio # of Building /Structure 494319AM0000
 Owner's name Plaza South Condominium Common Area 335 Units
 Owner's mailing address 4280 GALT OCEAN DRIVE, Ft. Laud., FL

Inspection Firm or Individual BROMLEY COOK ENGINEERING INC.
 Address 5440 NW 33 AVE SUITE 100, FT. LAUD., FL 33309
 Phone 954-772-4624

Inspection Commencement Date 08/23/21 Inspection Completion Date 09/ 17/ 21
 Inspection made by David Dolbee

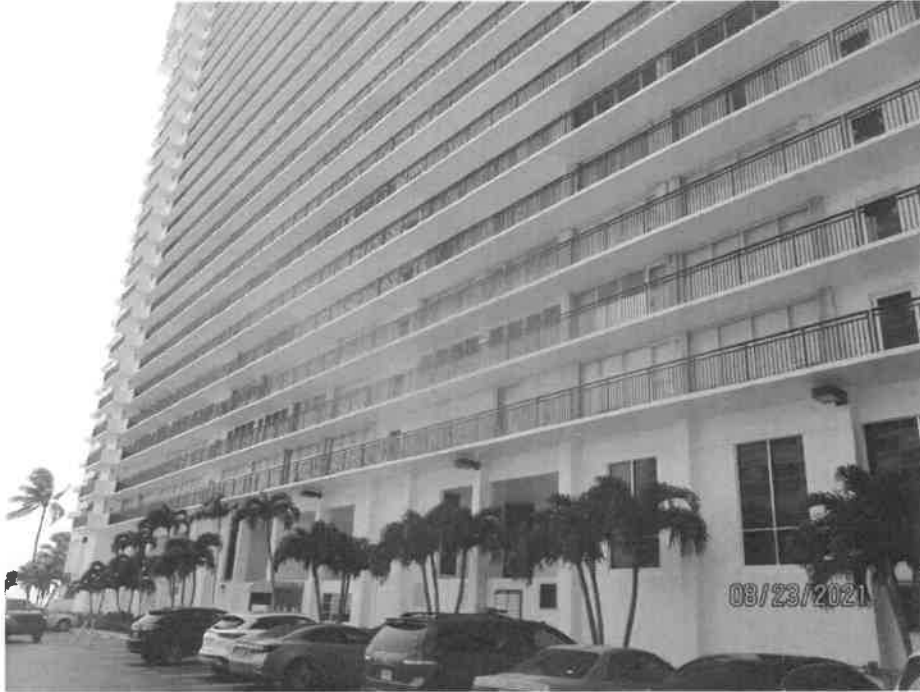
Photo at left depicts the north elevation of the condominium tower. This is an "T" shaped building with the west leg parallel to A1A. This building is located directly on the ocean.

This is a 30-story building for the majority of the tower, but there is a 16-story portion and a 28-story portion.
